# Killin and Ardeonaig Parish Church Feasibility Study

December 2020

A costed quinquennial survey was carried out by Adams Napier Partnership during October 2018 (Appendix C). Following this, a structural survey of the bell tower and cupola was carried out by David Narro Associates in January 2020 (Appendix D).

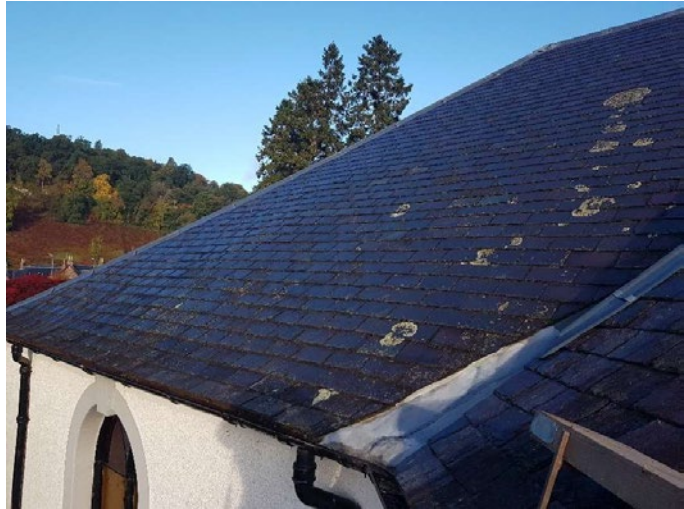
15

**Roofs:**  
Church main roof pitches are generally well maintained and in fair condition.

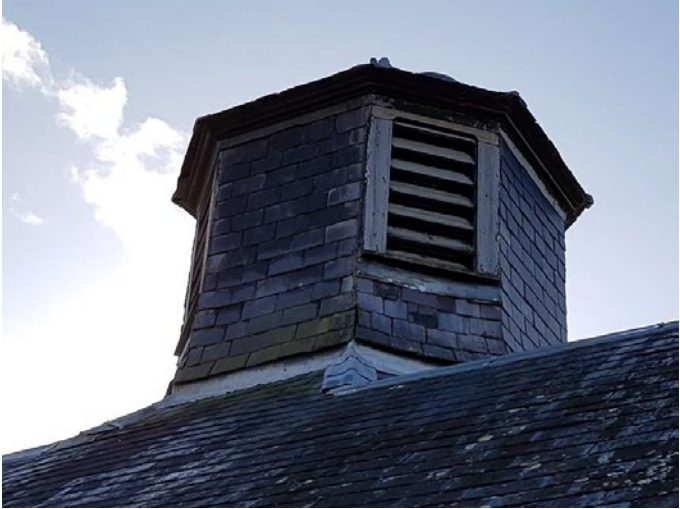
18

**Roofs:**  
Deterioration to timber louvres and fascias. Cracked slates, patched leadwork. Open joints around timber louvres and slating.

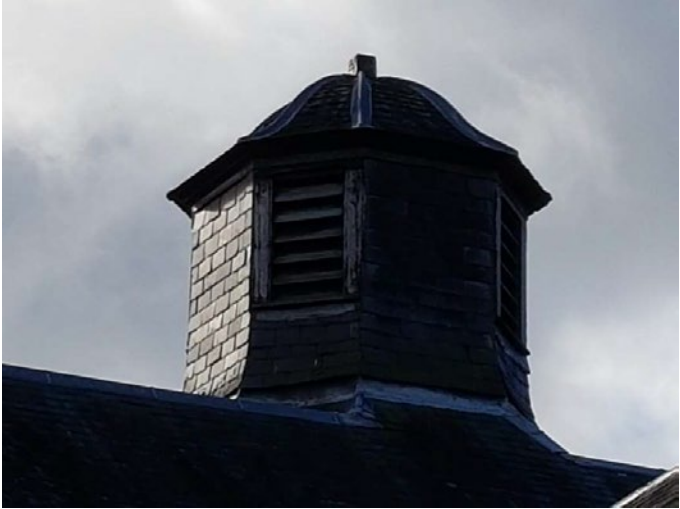
19

**Roofs:**  
Deterioration to timber louvres and fascias. Cracked slates, patched leadwork. Open joints around timber louvres and slating.

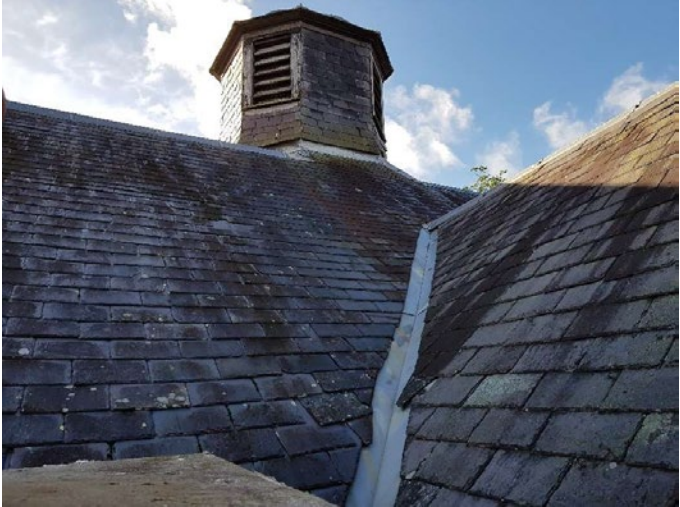
20

**Roofs:**  
Slipped and missing slates.

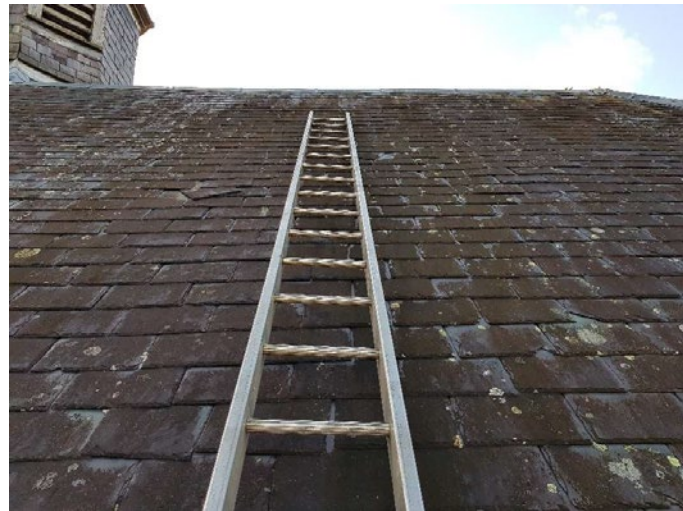
21

**Roofs:**  
Slipped and cracked slates.

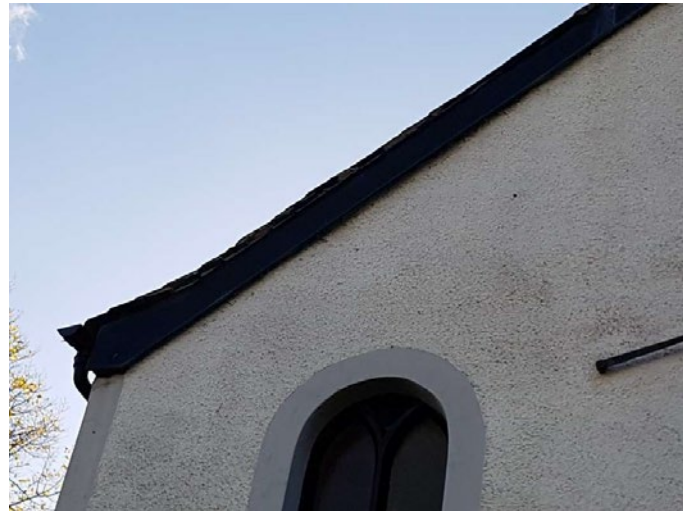
22

**Roofs:**  
Cracked and missing pointing to verge of north elevation slating.

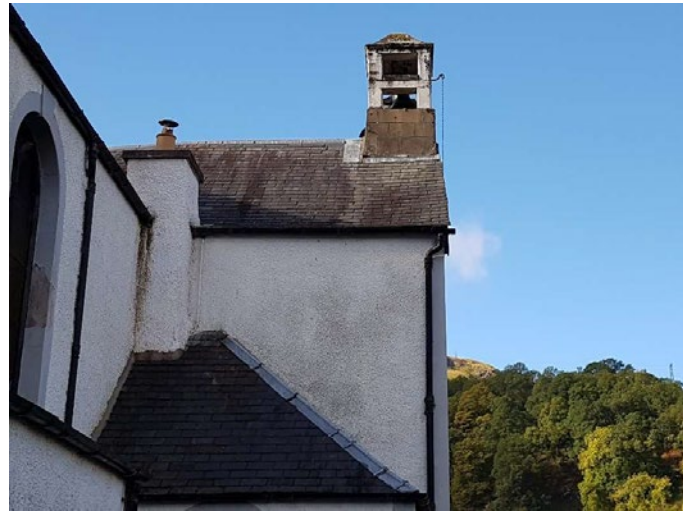
23

**Roofs:**  
Stonework to bell tower appears to be out of plumb.

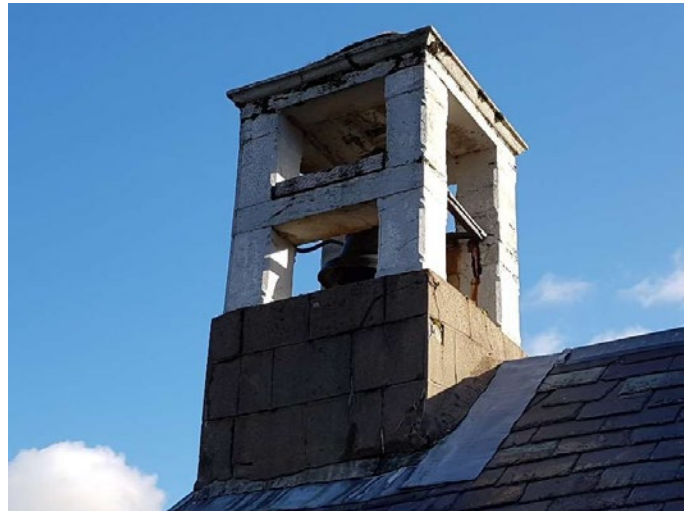
25

**Roofs:**  
Cracked and spalling render to base of bell tower. Metal fixings corroding and cracks apparent in surrounding masonry. Stonework decorated with masonry paint, moss and algae growth.

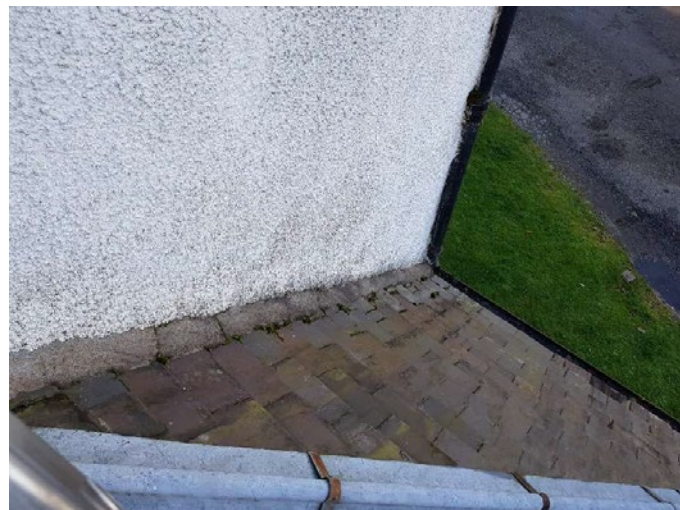
27

Hairline cracks to cement skew fillet of boiler house roof.

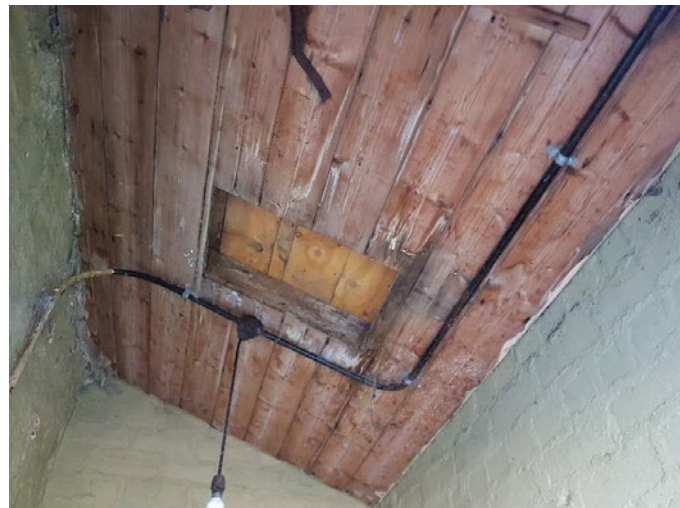
28

Lean-to, rooflight removed and boarded over in past. Staining of timber lined ceiling (assumed to be historic issue from when rooflight in place).

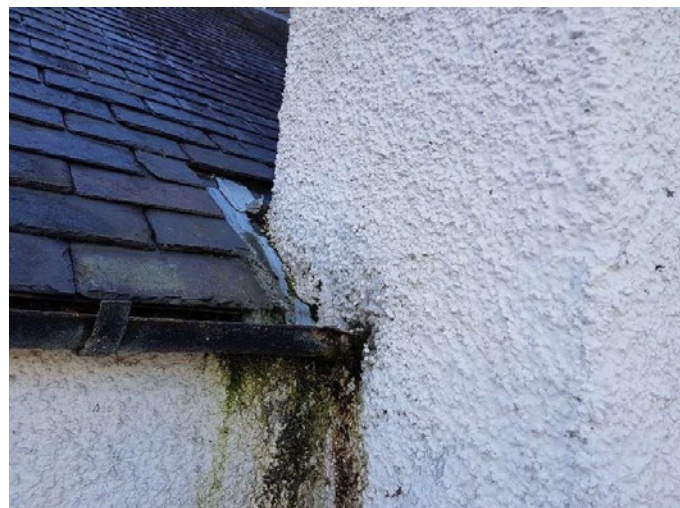
29

'Flashband' temporary repair to leadwork at base of chimney. Defective guttering where abuts chimney causing water runs off and staining of harling below.

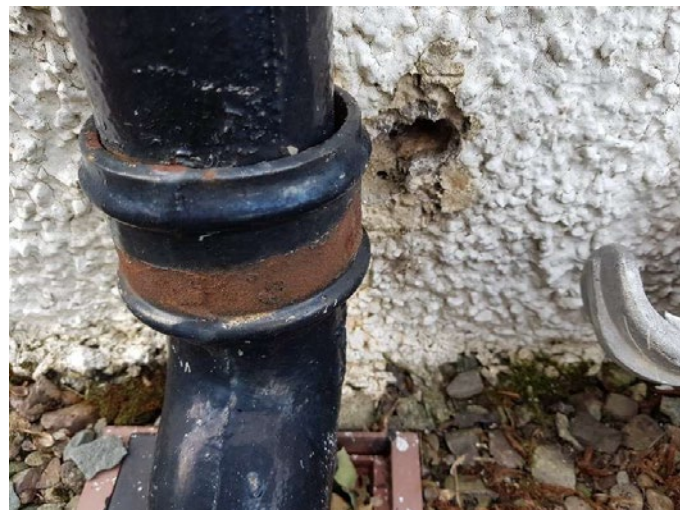
33

Missing downpipe bracket.  
Surface corrosion and flaking  
paint. No caulking of joints.

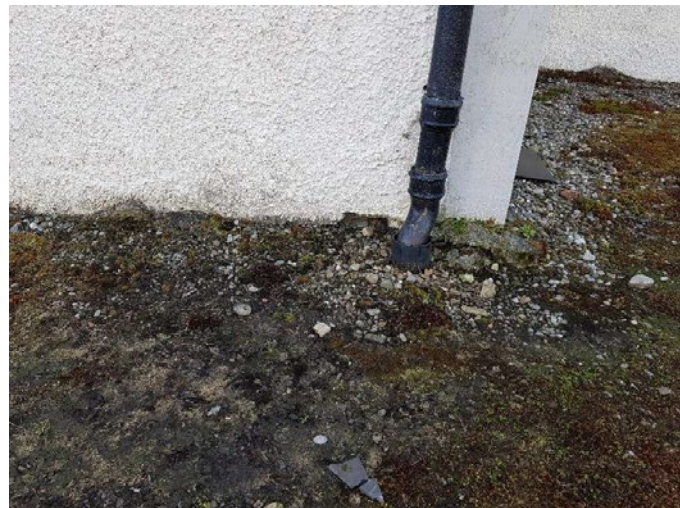
34

Open connections at base of  
downpipe into underground  
drainage system.

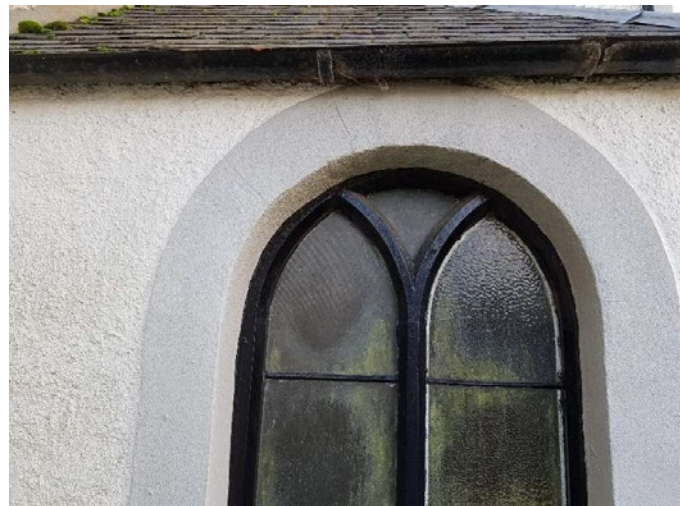
35

Staining to underside of gutter  
joint indicates leaking.

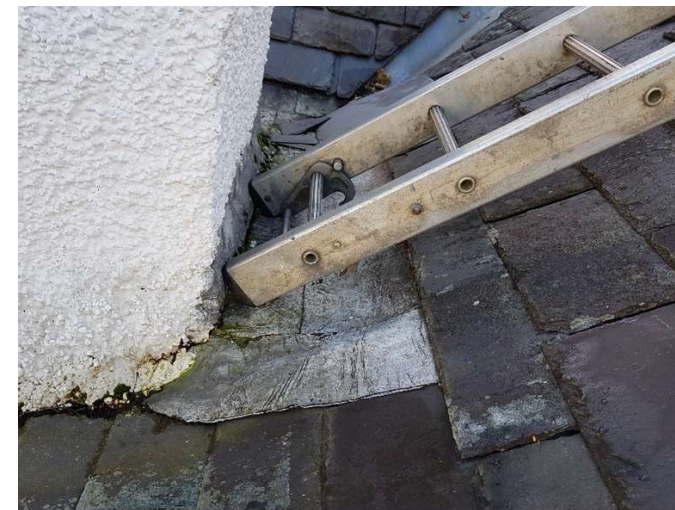
35

'Flashband' temporary repairs  
to leadwork at base of  
chimney. Minor cracking to  
chimney render.

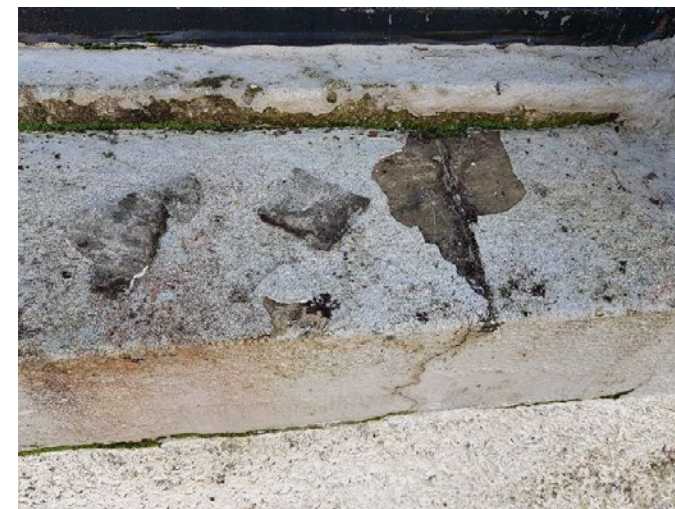
37

Use of impermeable masonry  
paints on stonework flaking off  
in places. Algae staining  
paintwork.

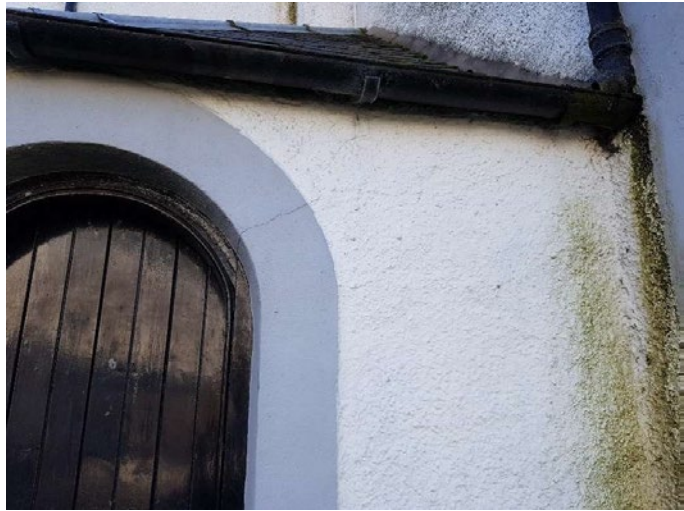
38

**North Elevation Boiler House:**  
Cracks in door margin and harling above. Defective gutter staining wall below.

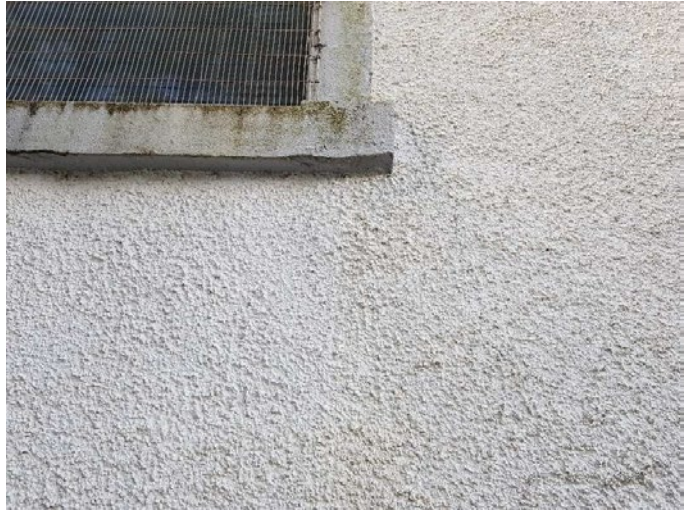
39

**East Elevation:**  
Cracks in harling extending down from window cill.

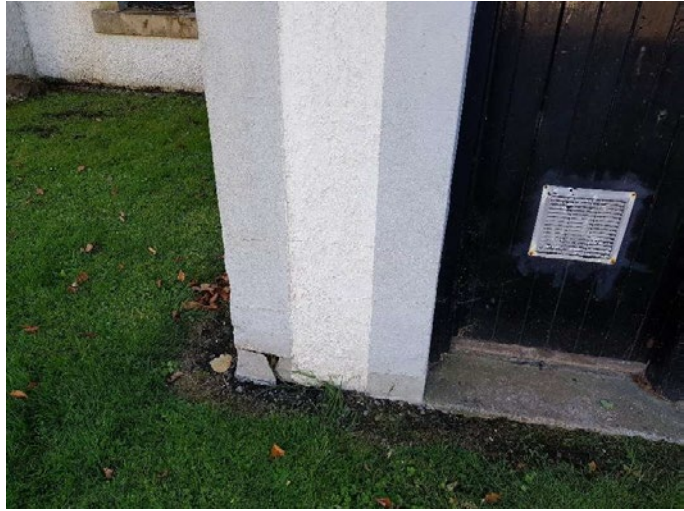
40

**North Elevation:**  
Cracked and spalling render at base of wall to boiler house extension to north. Plastic vent to door.

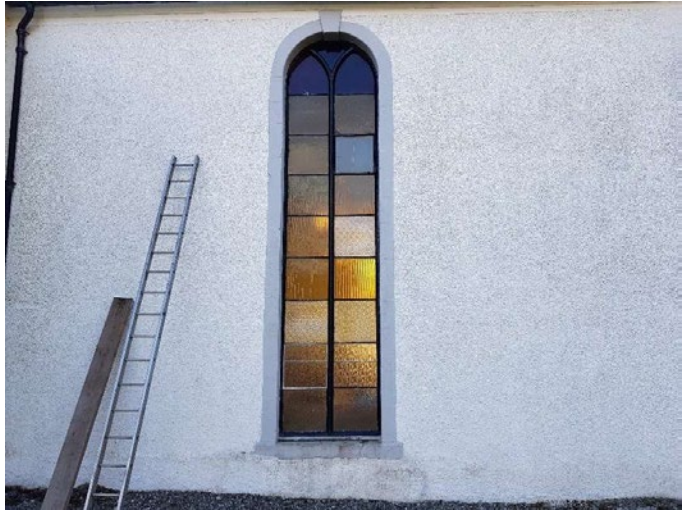
42

**Windows:**  
Different types and colours of glass used for previous repairs which has detracted from aesthetic appearance of windows. Assessment of the significance of the historic glass and original colour scheme needed to inform future repairs.

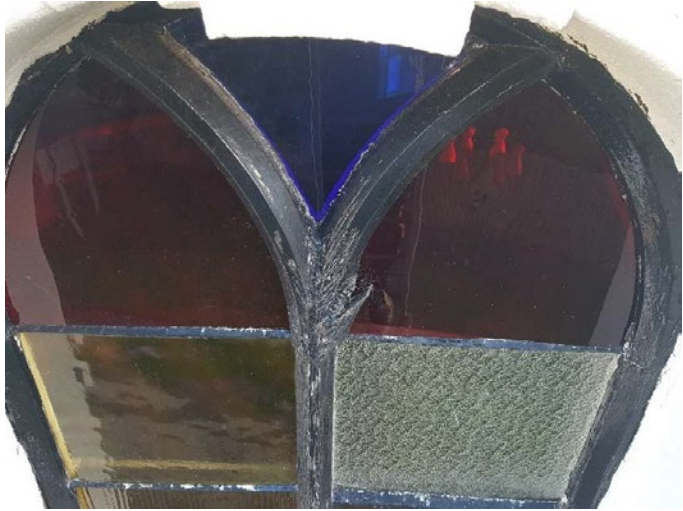
43

**Windows:**  
Defective timber at 'Y' intersection. Different styles and colours of glass used for previous repairs (clear white glass assumed not to be a later replacement).

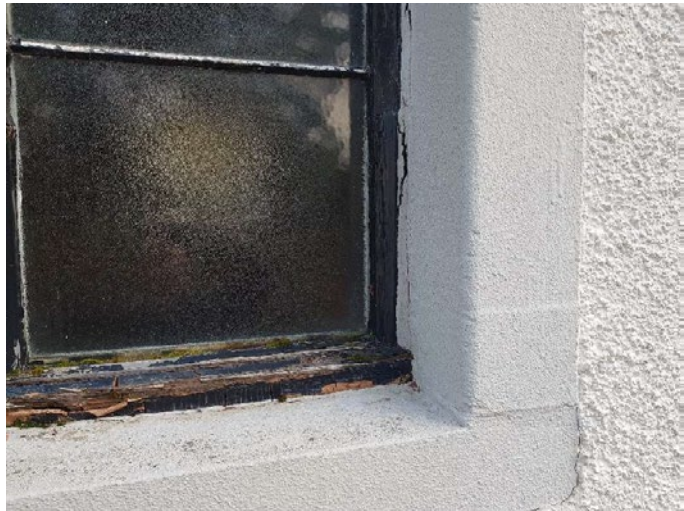
45

**Windows:**  
Extensive rot to window cill and  
lower part of frames. Moss  
growth. Cracked pointing  
around windows. Paint finish  
flaking.

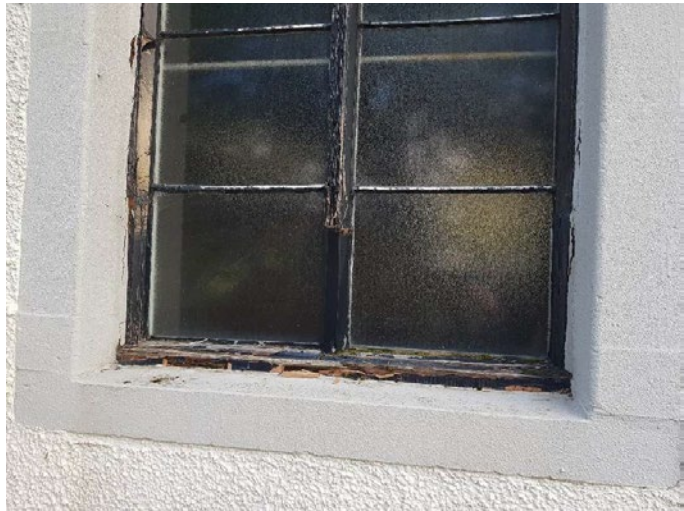
46

**Windows:**  
Window cill and lower part of  
frames rotten. Previous splice  
repairs to base of window  
frames. Painted decoration  
flaking. Cracked pointing  
around windows.

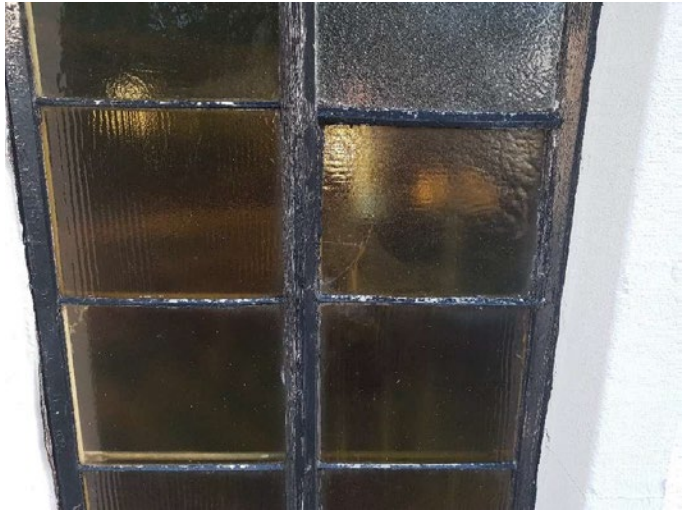
47

**Windows:**  
Cracked pane of glass to south  
west facing window of octagon.  
Different styles and colours of  
glass used in previous repairs.

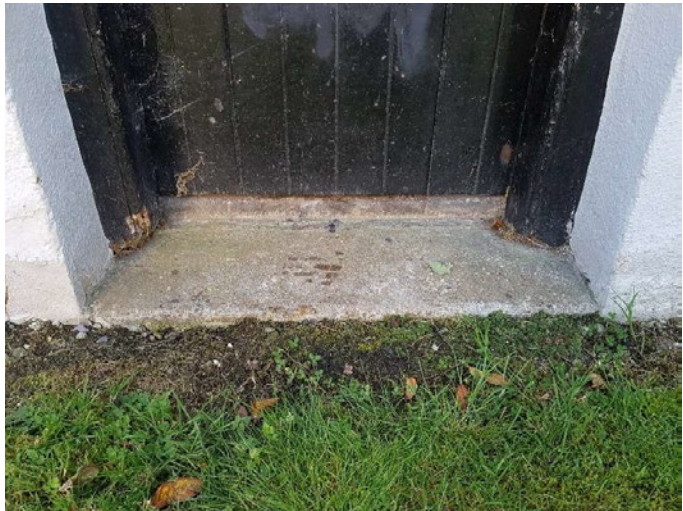
48

**Doors:**  
Base of timber door standards  
rotten to boiler house.

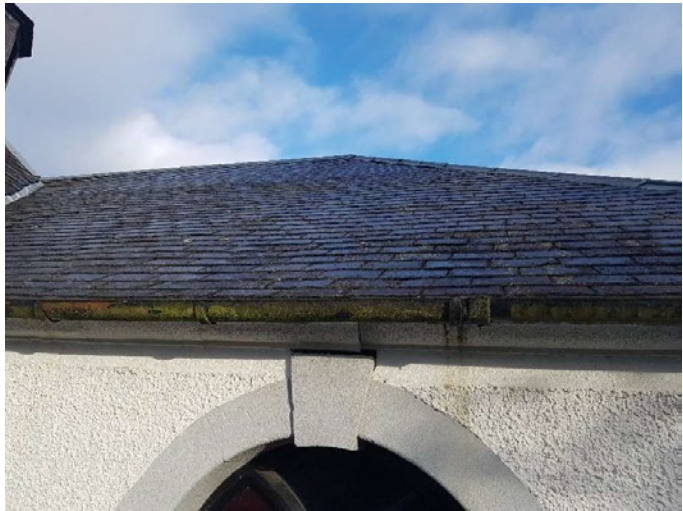
49

**South Elevation:**  
Displaced key stone and eaves  
cornice above church window  
with gap above. Flaking paint  
and algae staining to gutters.

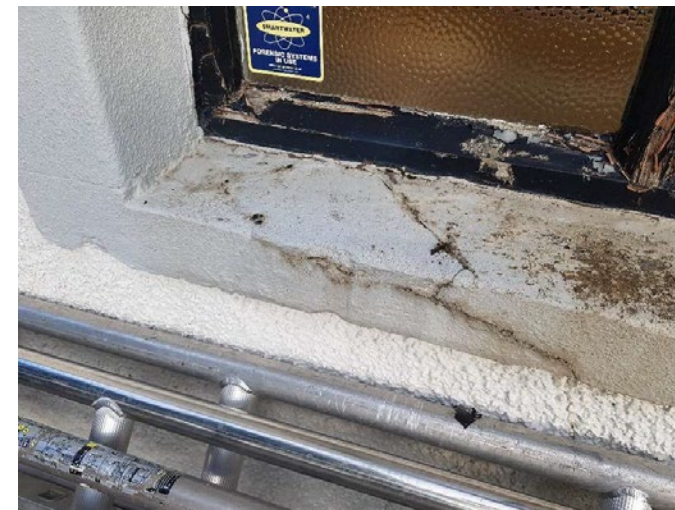
53

**South Elevation:**  
Cracking to stone window cill and harling below. Rotten cill and base of frames to window.

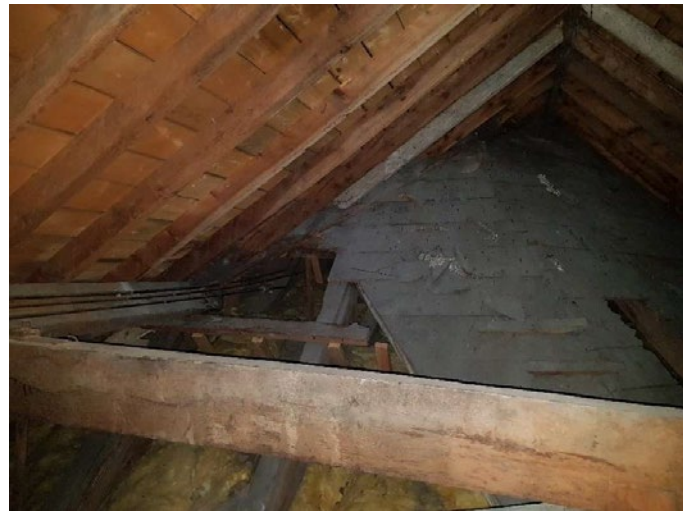
56

**Roofspace:**  
Remains of earlier roof structure in roofspace.

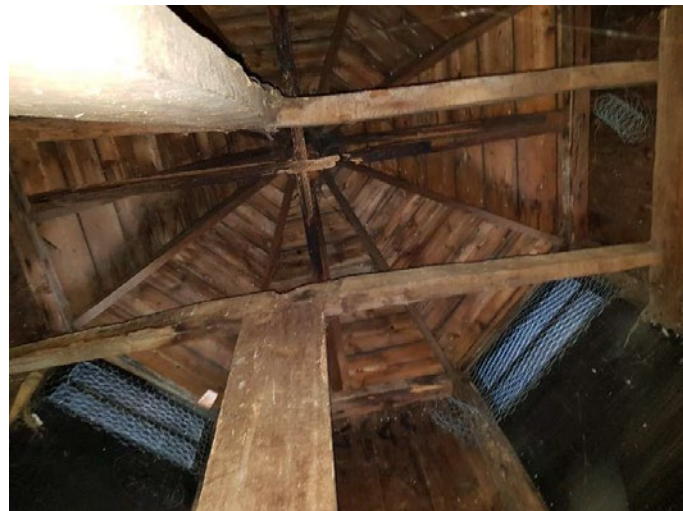
58

**Roofspace:**  
Broken horizontal tie to cupola.

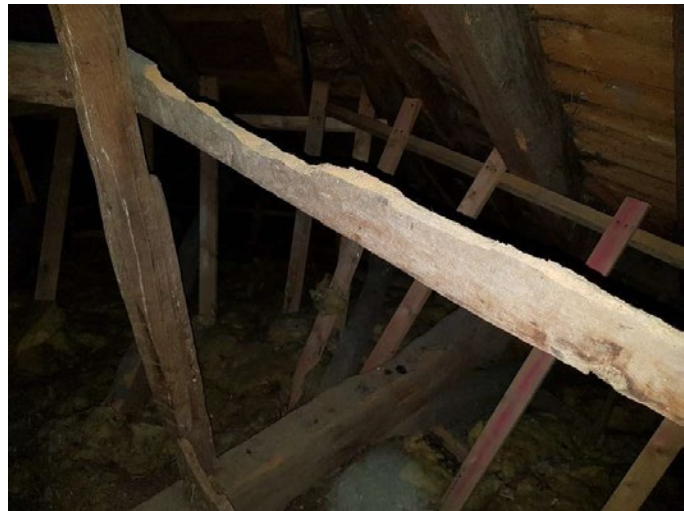
59

**Roofspace:**  
Deterioration to roof timbers from insect attack.

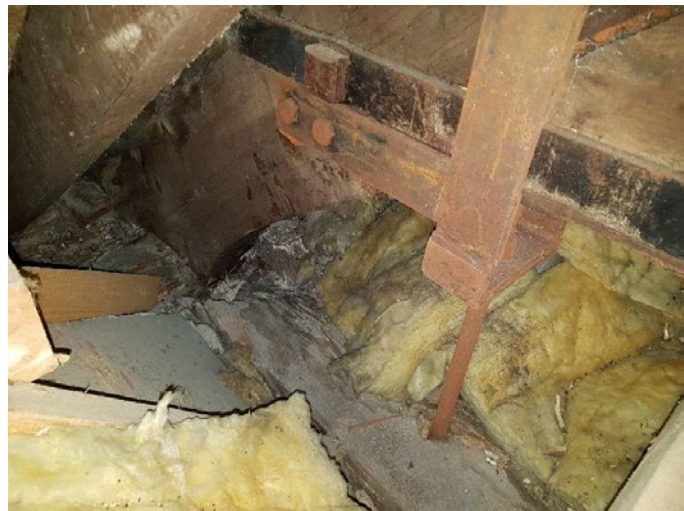
60

**Roofspace:**  
Staining of roof timbers and wet rot to rafters to south side of church. This is believed to be historic as it is understood repairs have now been made to replace valley flashing above.

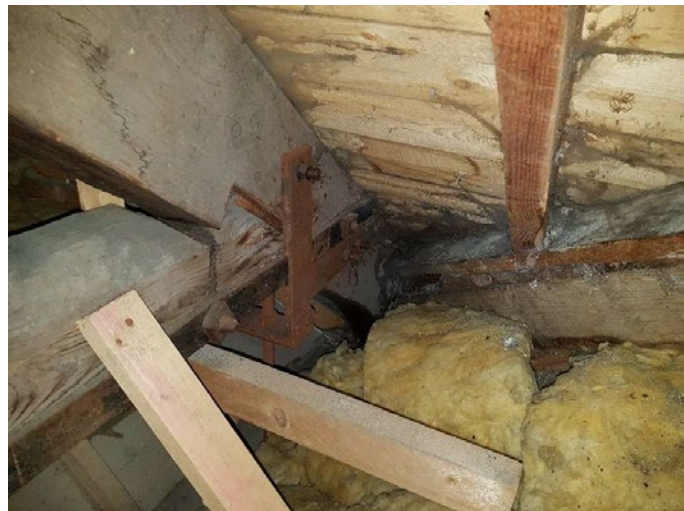
61

**Roofspace:**  
Some movement in main elements of timber roof structure apparent to south side of church. Metal bracing may be earlier repair to arrest structural movement and should be inspected by Structural Engineer.

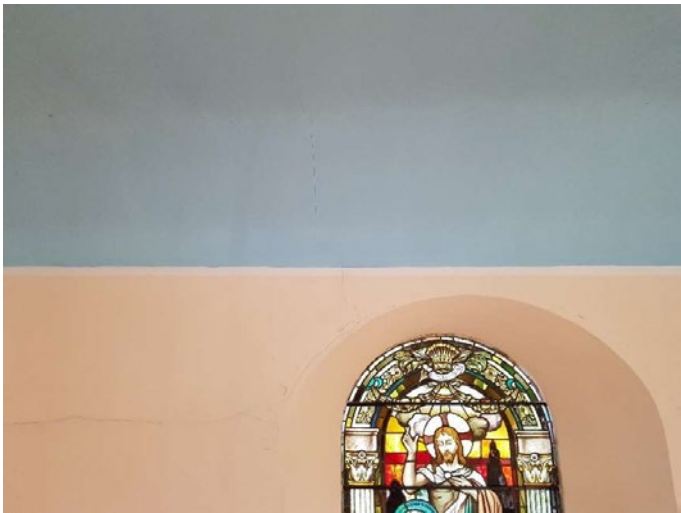
63

**Church East Wall / Ceiling:**  
Cracks in plaster wall and ceiling finishes around stained glass window.

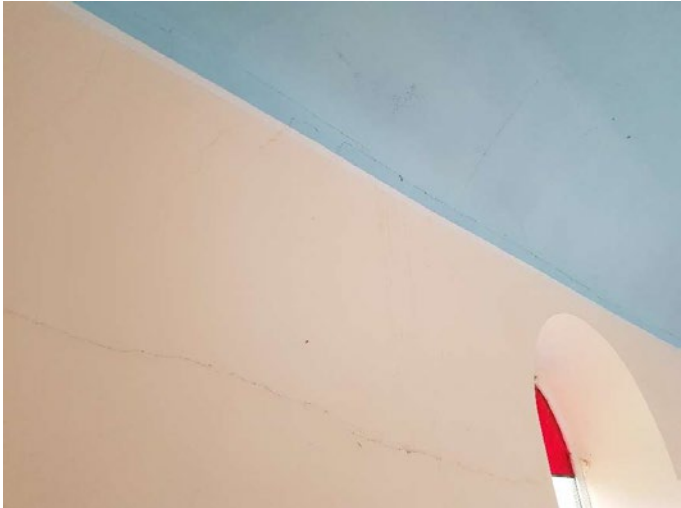
64

**North Wall:**  
Extensive cracking to plasterwork ceiling and walls.

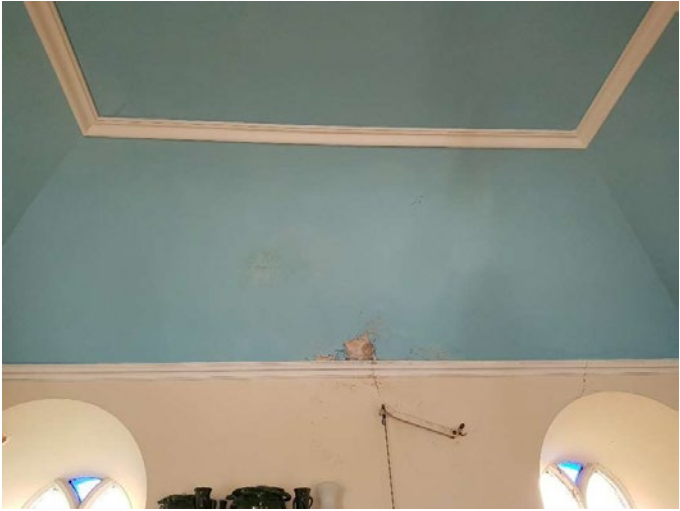
65

**Gallery Ceiling:**  
Cracking to plaster and flaking of paint to ceiling and wall finishes.

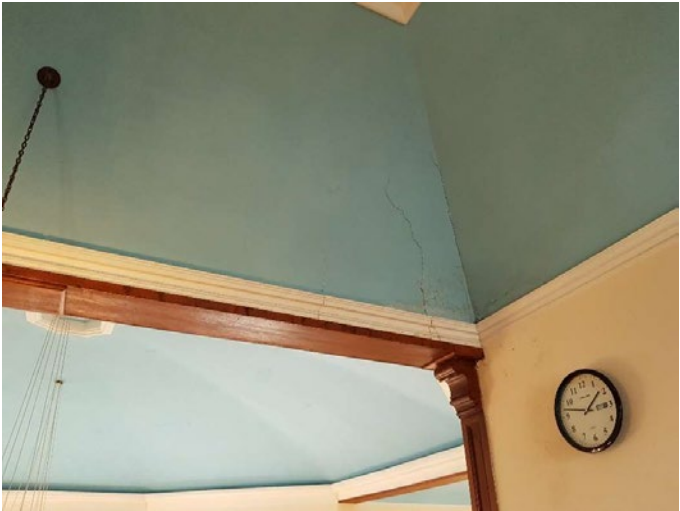
66

**Gallery:**  
Cracking to plaster above gallery.

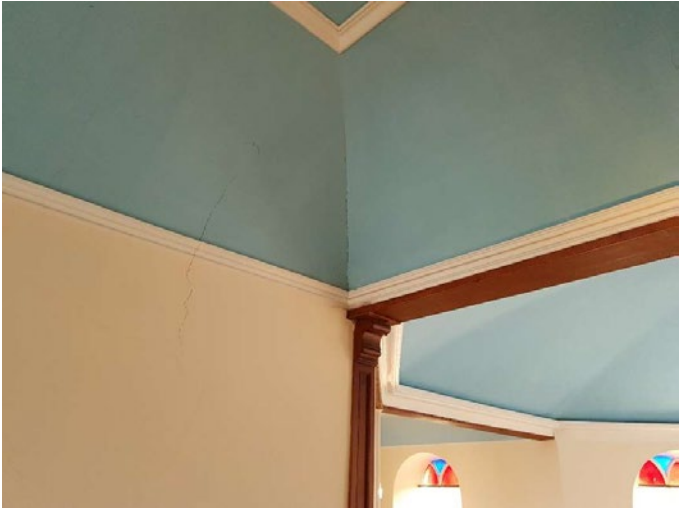
67

**Gallery:**  
Vertical cracking to plaster and cornice.

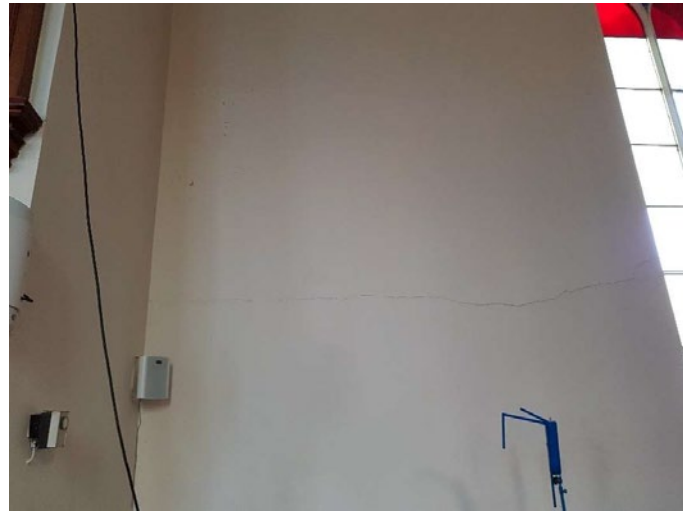
68

**Sanctuary:**  
Horizontal cracking to plaster  
on north wall.

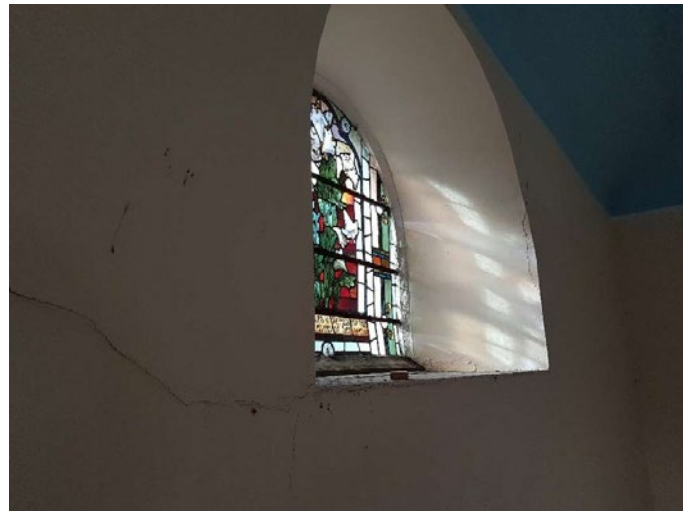
69

**West Wall:**  
Cracking to plasterwork around  
stained glass window.

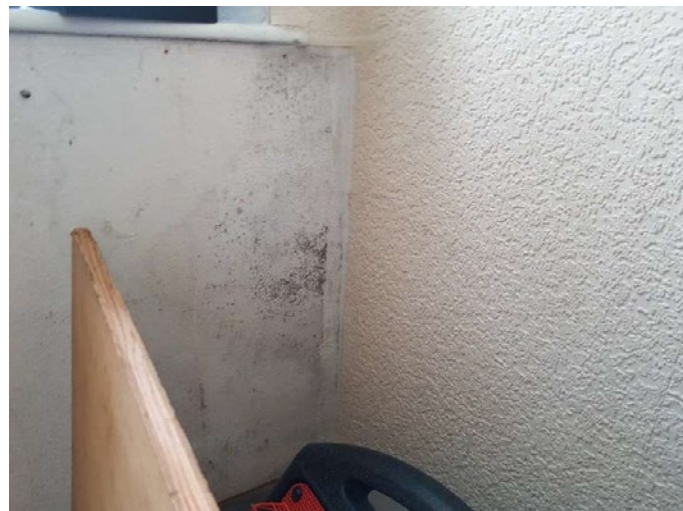
70

**North Extension:**  
Condensation staining and  
mould growth on east wall  
under window.

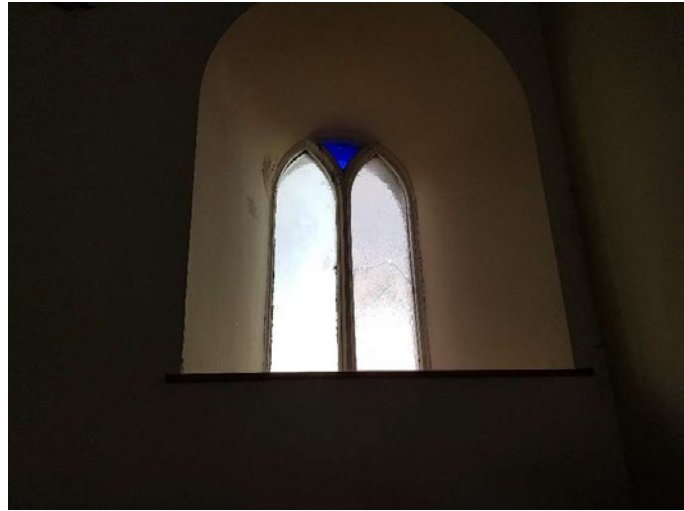
71

**Upper Gallery:**  
Broken pane of glass.

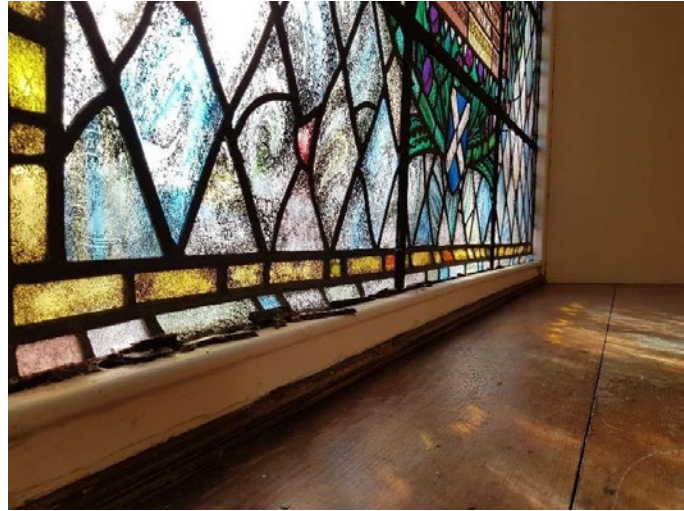
72

**Windows:**  
Defective putty and some  
distortion in lower part of  
leaded stained glass window.

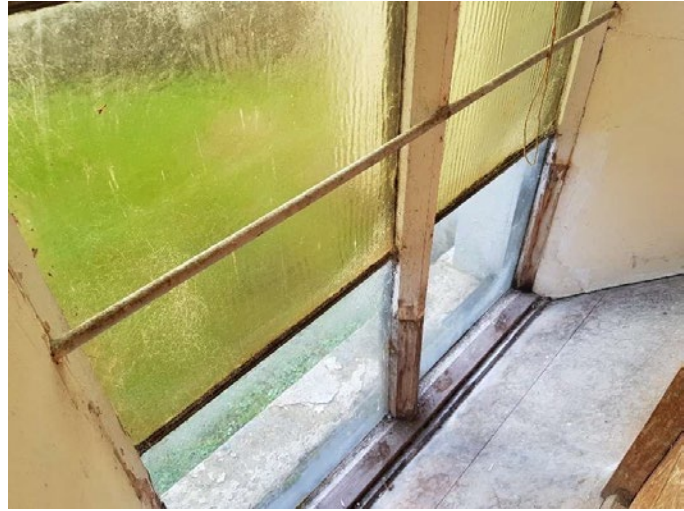
73

**Windows:**  
Previous timber splice repairs  
at base of windows.  
Inappropriate glazing  
replacements in clear glass.

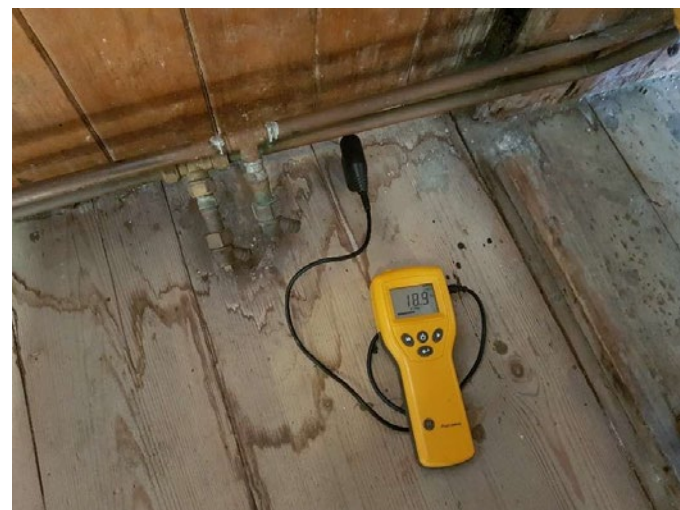
74

Staining to timber floorboards below central heating pipework. Higher than normal moisture content recorded in timber with meter indicating timber 'At Risk' of decay.

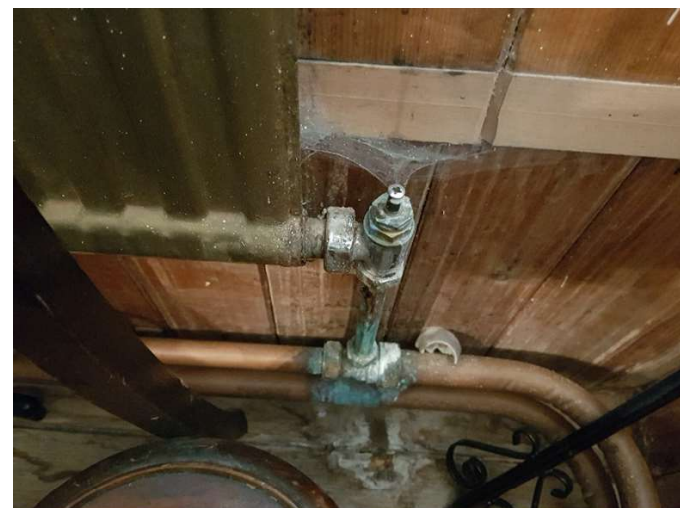
75

Leaking radiator pipework joint causing staining of floor finishes below and higher than normal moisture content with timber 'At Risk' of decay.

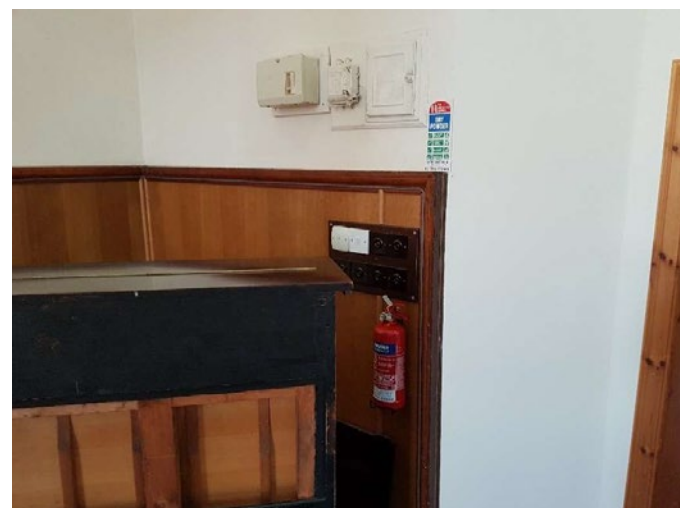
76

Aged electrical installation in process of getting replaced during inspection.

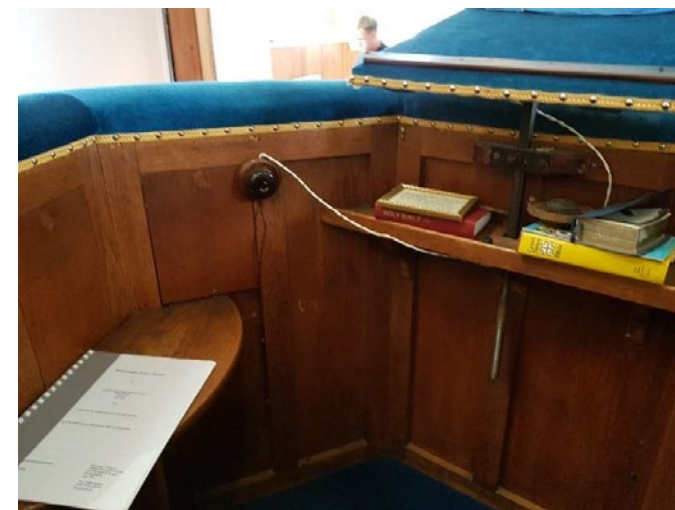
77

Aged electrical installation including bakelite switches on wooden backplates not to current standards for electrical installation (note: electrical installation getting replaced during inspection).

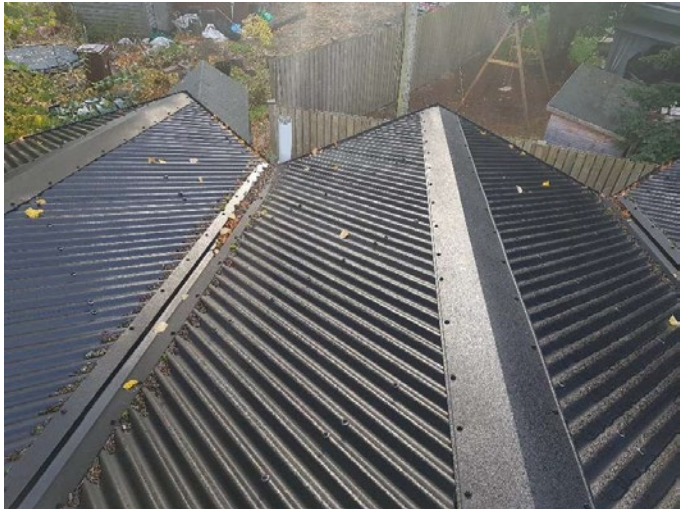
87

Modern corrugated metal roofing with pvc coated finish. Gutters filled with leaves and other debris. Moss growth.

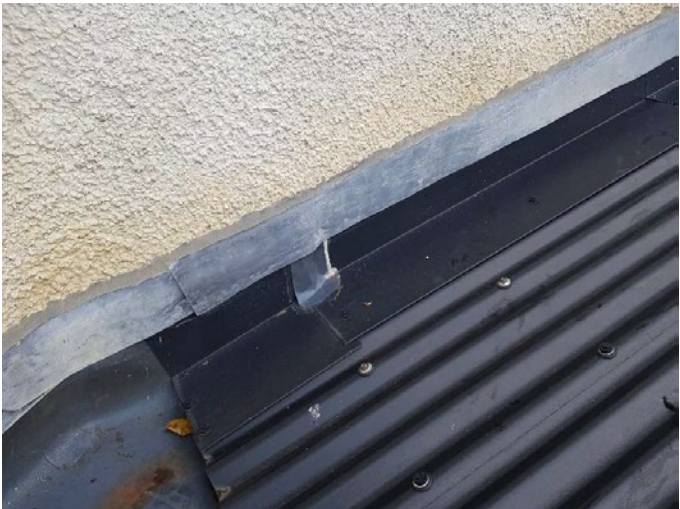
90

Patch repair to joint in proprietary flashing sealed with silicone.

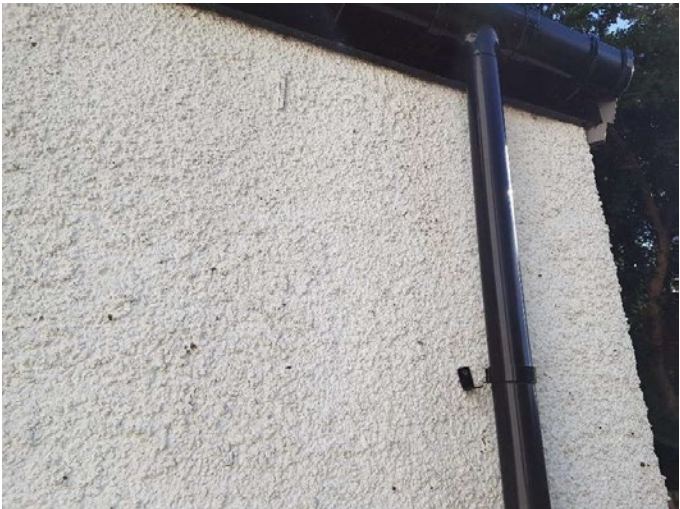
91

Broken downpipe bracket.

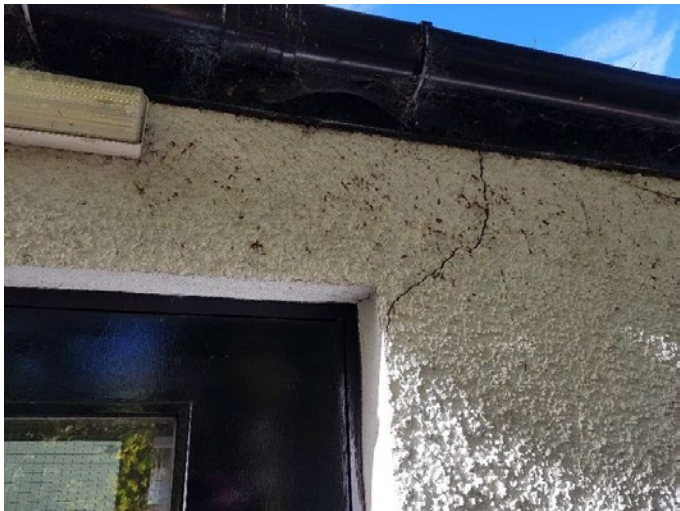
92

**Walls:**  
Crack in render above fire exit door to east elevation.

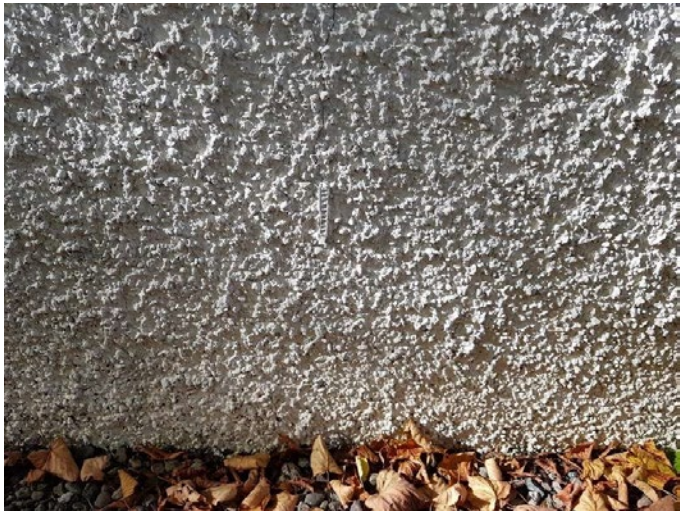
93

**Walls:**  
Hairline cracks in render.  
Cavity ventilators blocked.

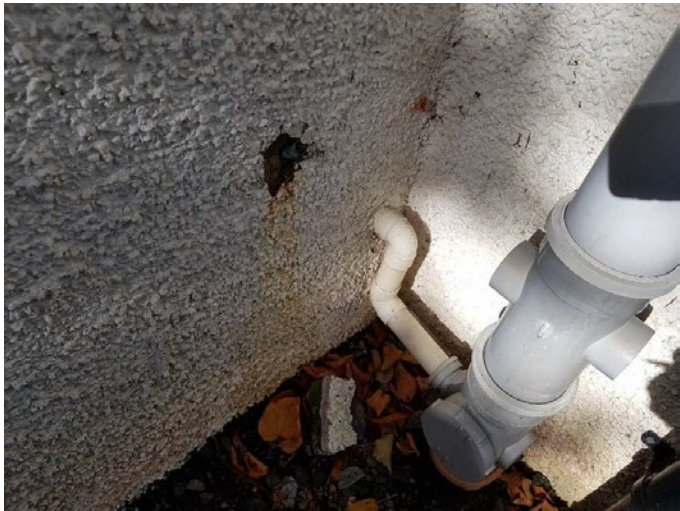
94

**Walls:**  
Damage to harling and staining to wall surfaces from leaking overflow pipe.

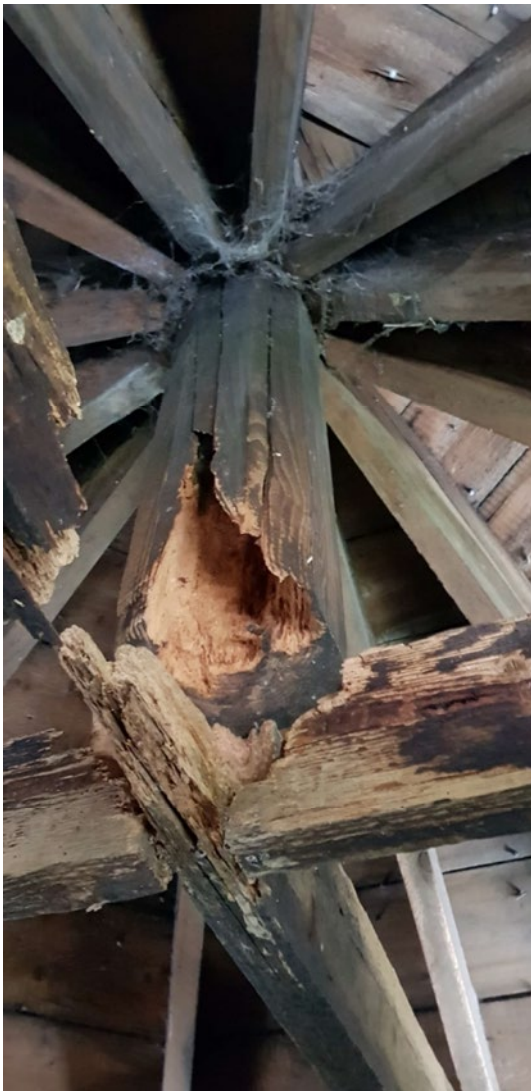
The structural timbers which form the cupola show clear signs of significant loss of section due to infestation. This has in some cases resulted in significant loss of structural capacity to individual members. In the case of the cross trees tie members a complete loss of section has occurred. A significant portion of the heart wood has been consumed within the vertical spire member above. Structural repair or replacement is required.

Photograph 6 – Significant section loss in cross tree members within cupola

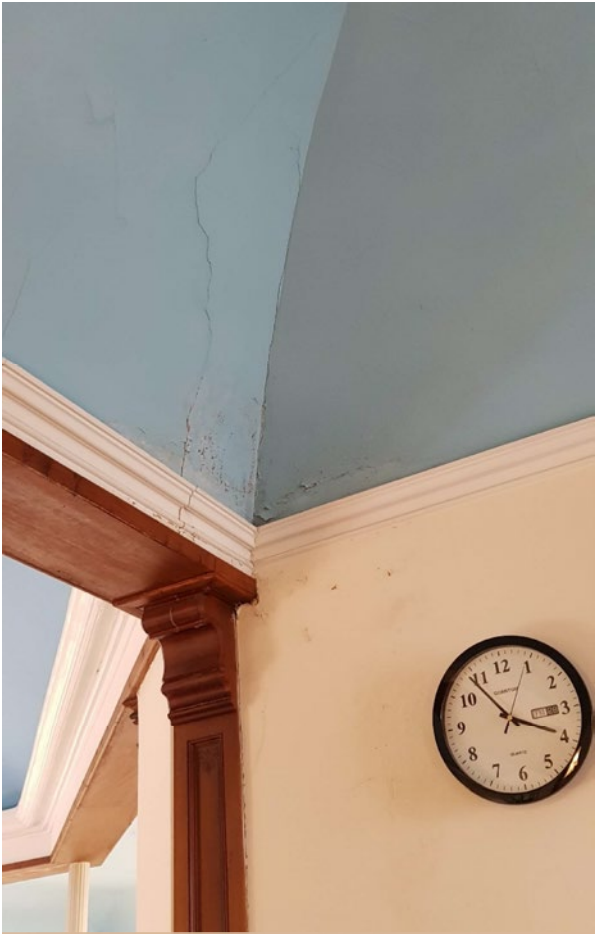
1. **Beam end to the west side of the north gallery.** The plasterwork cracking viewed may be indicative of distress in the structural member beyond. It was not possible to view this member from within the roof space intrusive investigation is therefore recommended to allow inspection of the structure beyond.

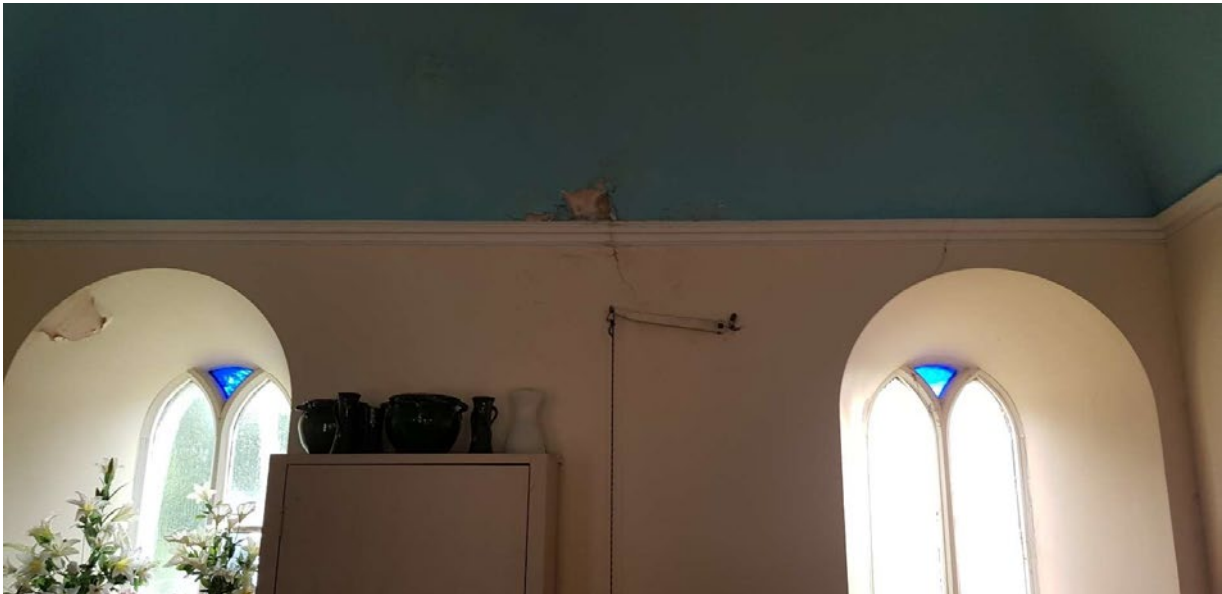
2. **Signs of water ingress below the north bellcote.** Further investigation is recommended to determine whether the structural support to the bell tower has been compromised.

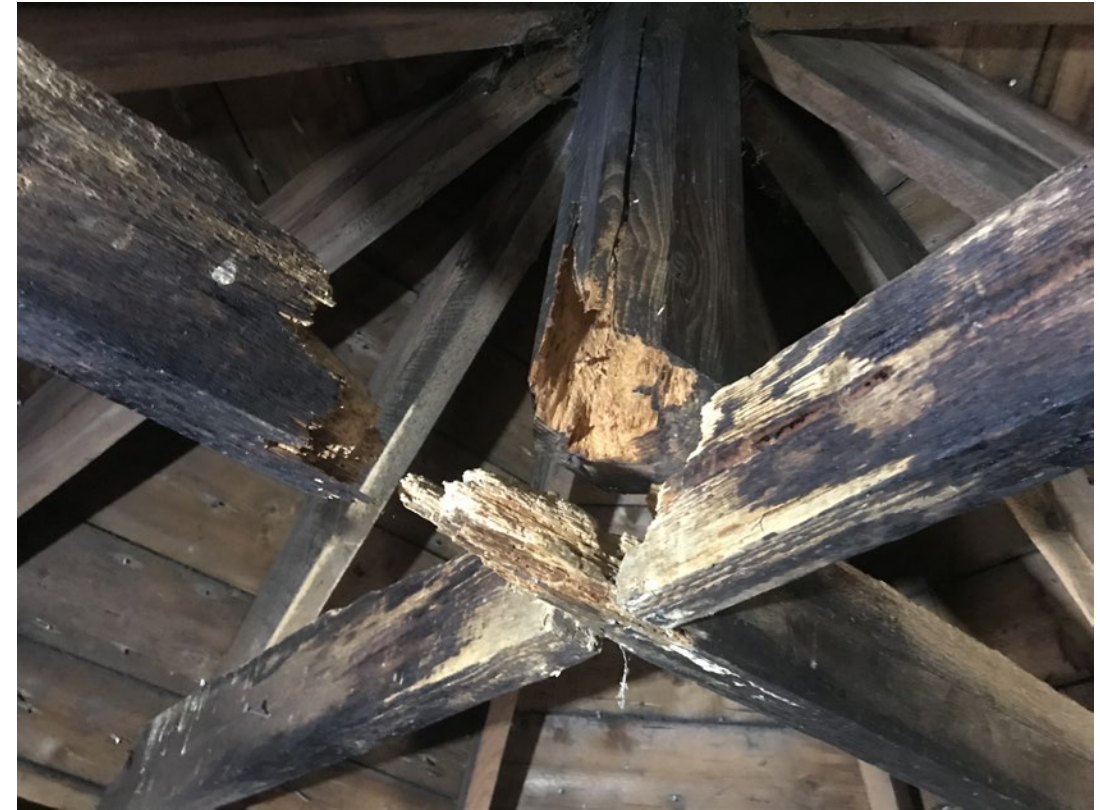
Base of the finial and support cross-ties degraded and decayed by surface/ rain water entering at the external lead covering. A repair will involve replacing the cross-ties, preparing and shuttering the finial base, and pouring structural resin into the void.
