# Killin and Ardeonaig Parish Church Feasibility Study

December 2020

A costed quinquennial survey was carried out by Adams Napier Partnership during October 2018 (Appendix C). Following this, a structural survey of the bell tower and cupola was carried out by David Narro Associates in January 2020 (Appendix D).

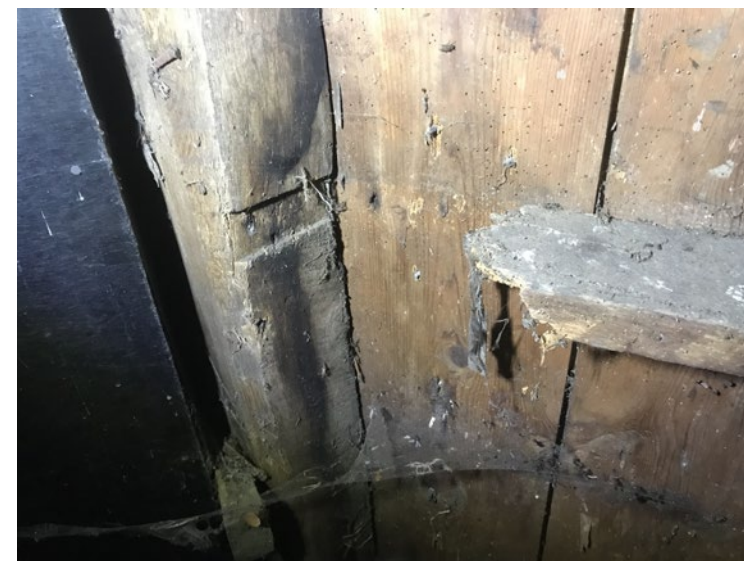
Intensely wood borer degraded softwood support member had been let-into the oak post

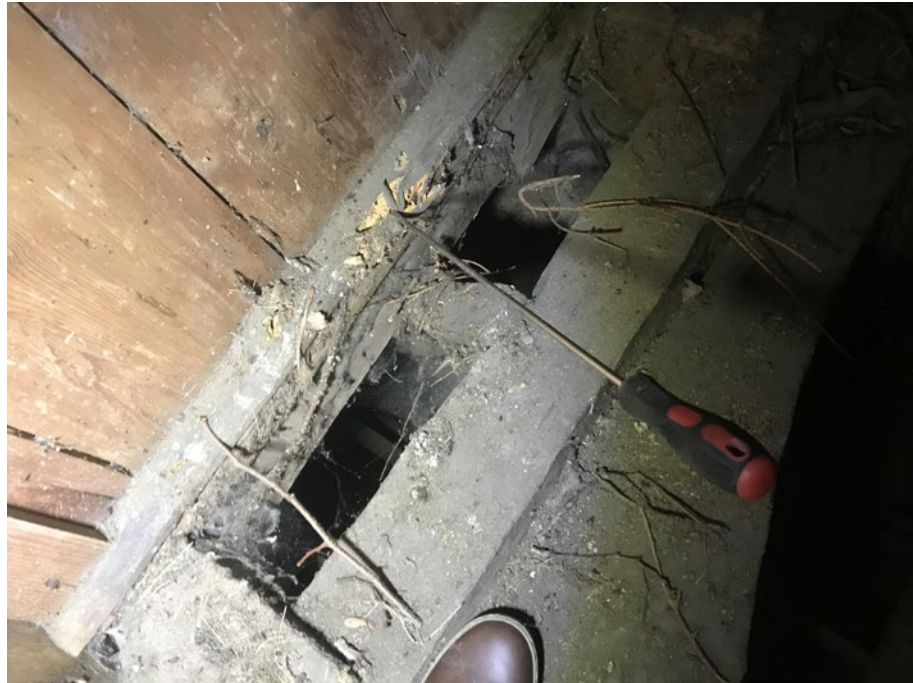
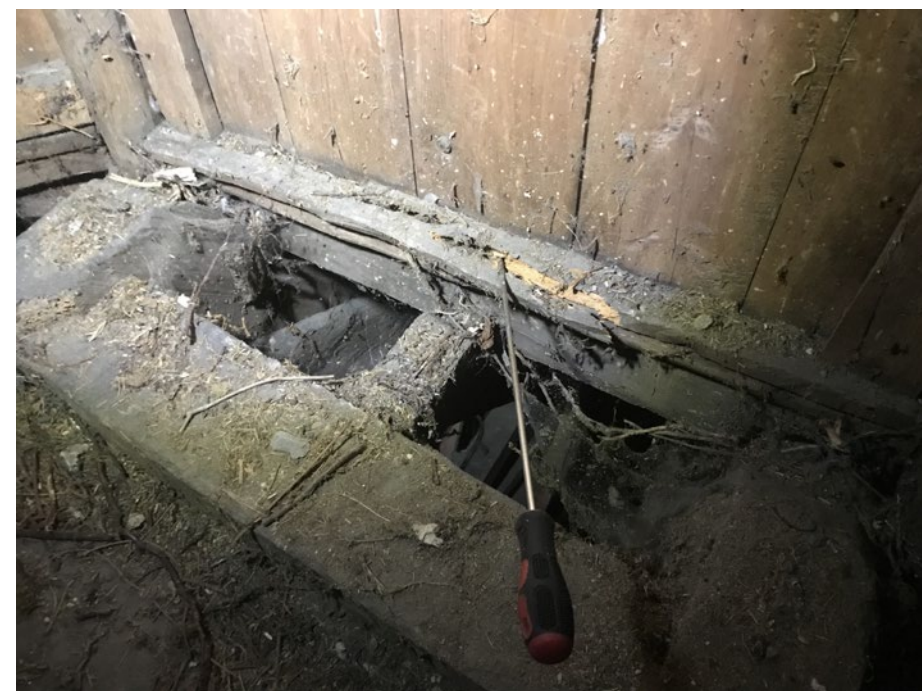
Woodworm degraded softwood plates above unaffected oak frames.

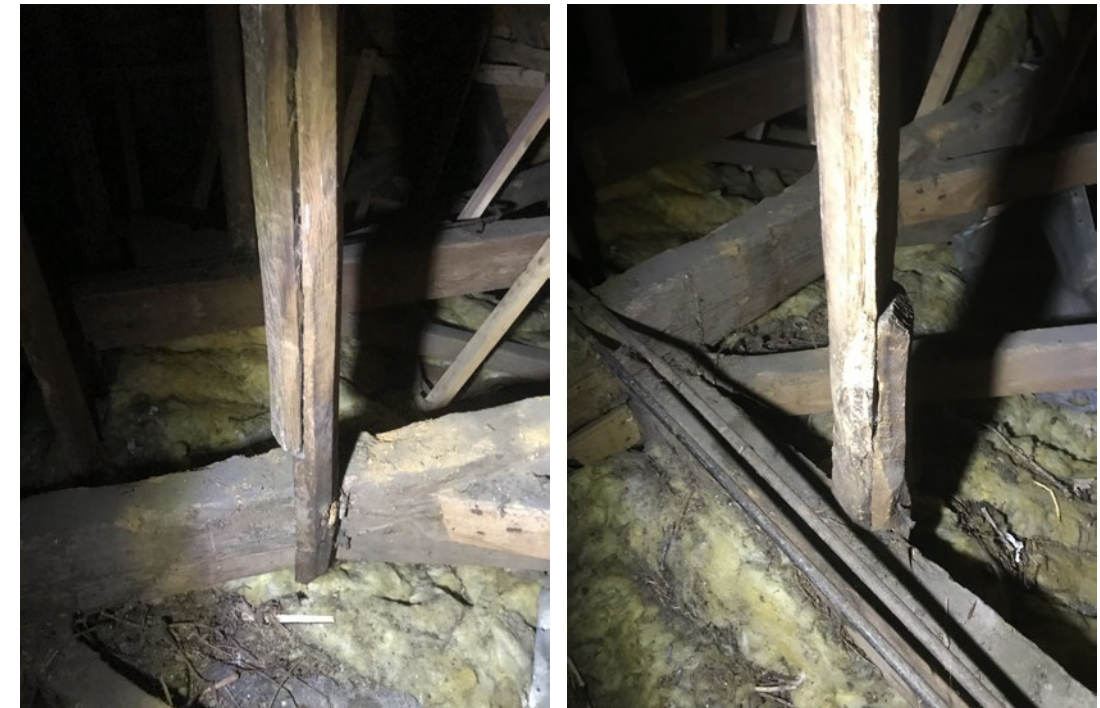
Base of oak posts: connections to principal truss collars and ties. It is recommended that these be inspected individually and strengthened with thixotropic resin injections at the oak to oak connections.
