# Killin and Ardeonaig Parish Church Feasibility Study

December 2020

A costed quinquennial survey was carried out by Adams Napier Partnership during October 2018 (Appendix C). Following this, a structural survey of the bell tower and cupola was carried out by David Narro Associates in January 2020 (Appendix D).

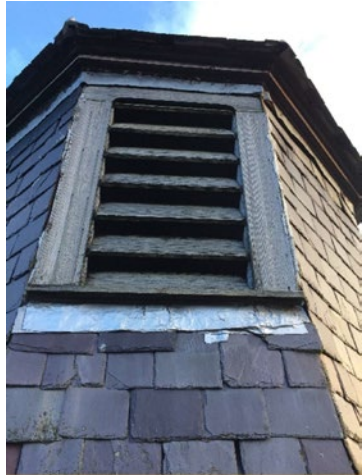
16

**Roofs:**  
'Flashband' temporary repairs and missing slate below window cill. Deterioration to timber louvres. Sealant around timber louvres cracked and missing in places.

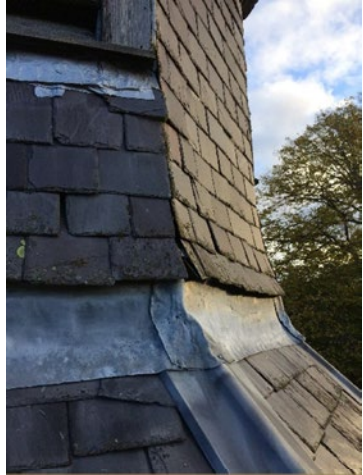
17

**Roofs:**  
'Flashband' temporary repairs and missing slate below window cill. Open joints between slates on angle could allow water to penetrate (note: timber rafter below this area in roofspace heavily decayed).

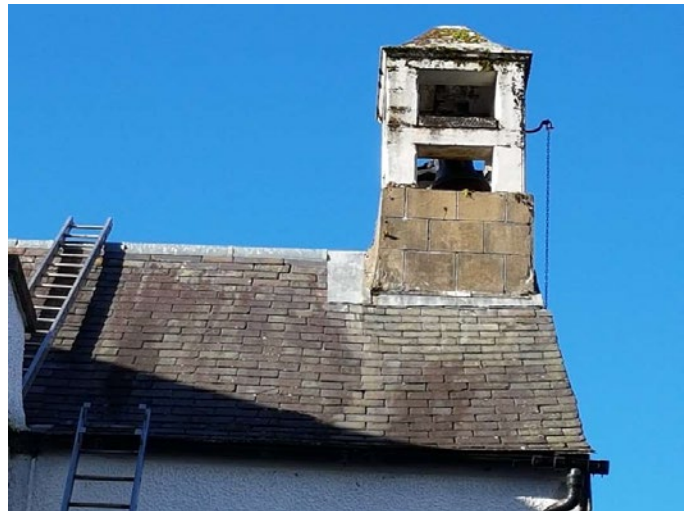
24

**Roofs:**  
Stonework to bell tower appears to be out of plumb. Stonework heavily moss covered.

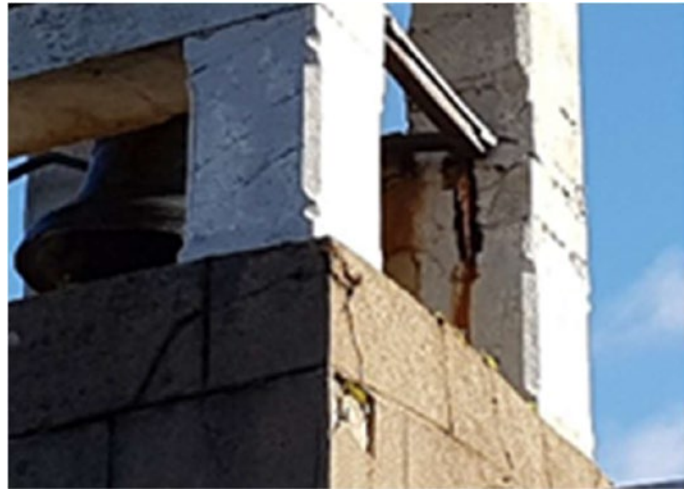
26

**Roofs:**  
Cracked and spalling render to base of bell tower. Metal fixings corroding and cracks apparent in surrounding masonry.

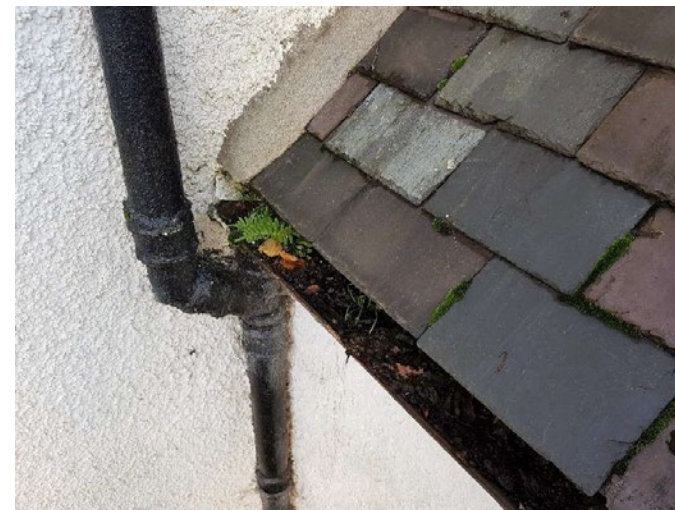
30

Debris and vegetation in gutter of single storey boiler house to north.

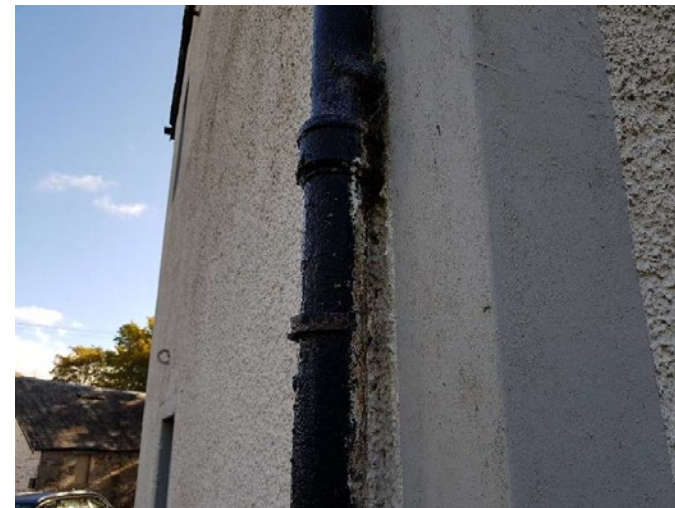
31

Corrosion to back of rainwater downpipe. Downpipe harled

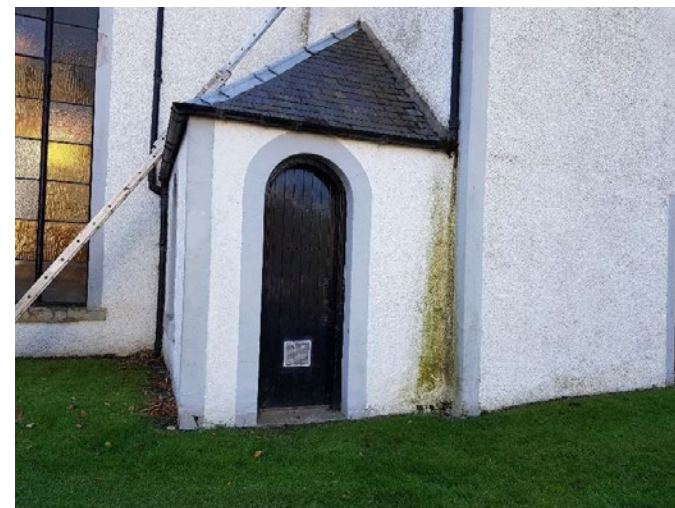
32

Defective guttering where extension abuts main building causing staining to wall surfaces below.

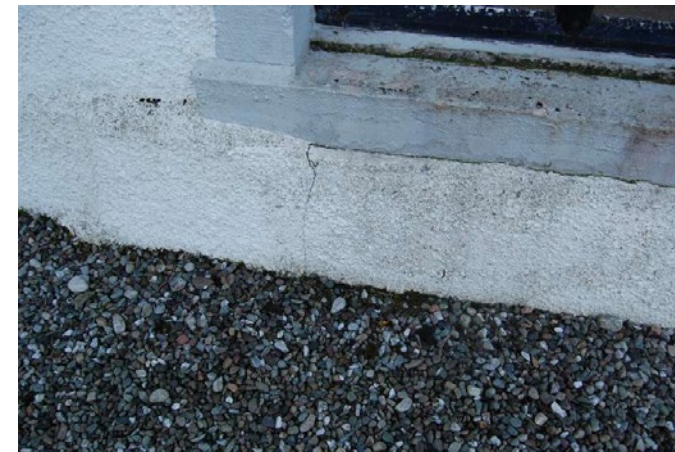
36

Cracking to harling under  
window. Stone windows  
surround decorated with  
masonry paint.

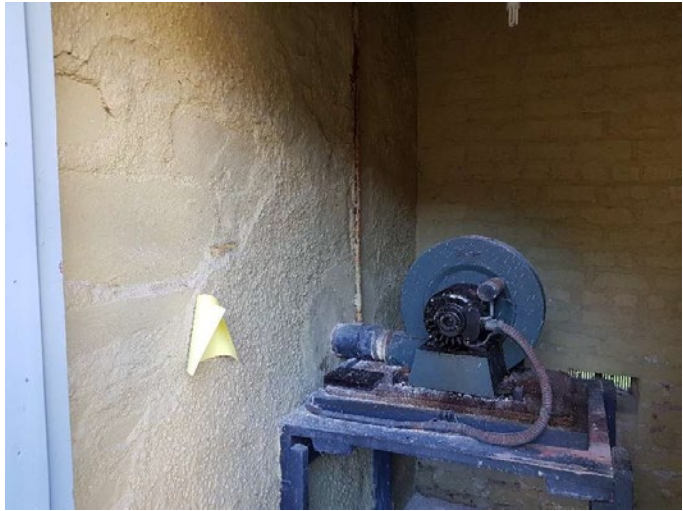
41

**North Elevation Lean-to:**  
Organ blower machine. Evidence of earlier harl on walls.

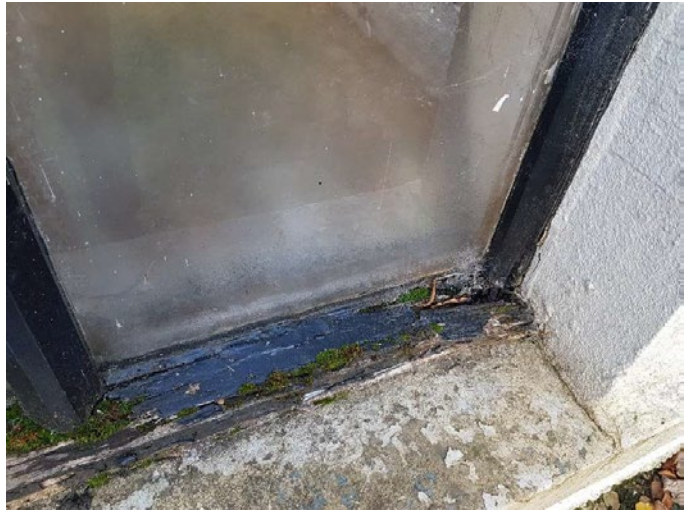
44

**Windows:**  
Sanctuary North Elevation -  
Rotten timber window cill and  
frames. Paint finish flaking.

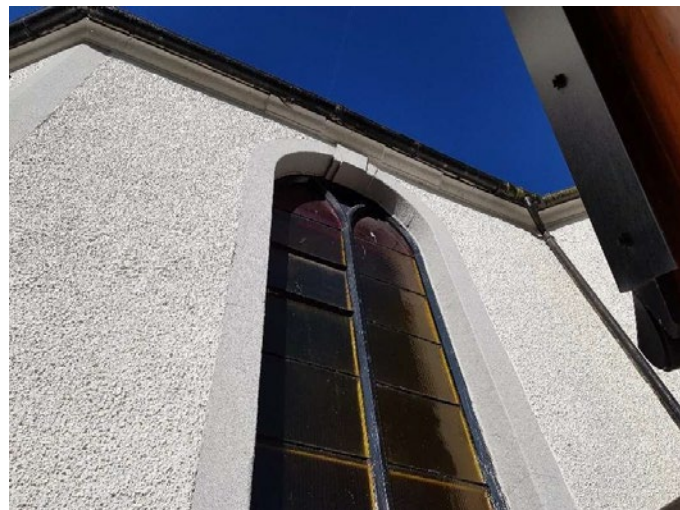
50

**South Elevation:**  
Displaced key stone and eaves cornice above church window.

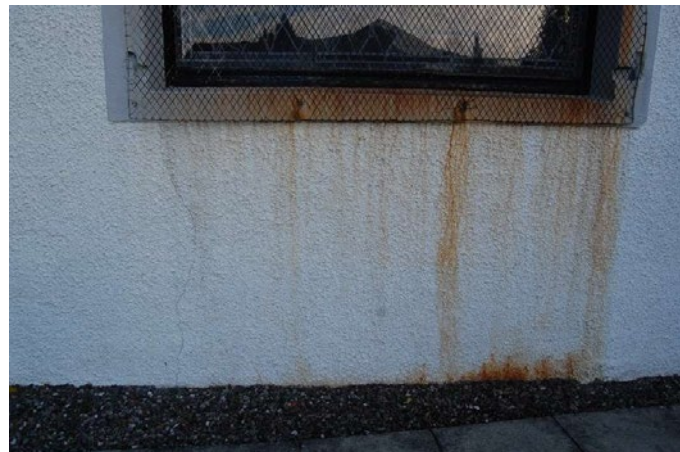
51

**South Elevation:**  
Crack in render below window. Staining of wall finishes from corrosion of metal grille and fixings over window.

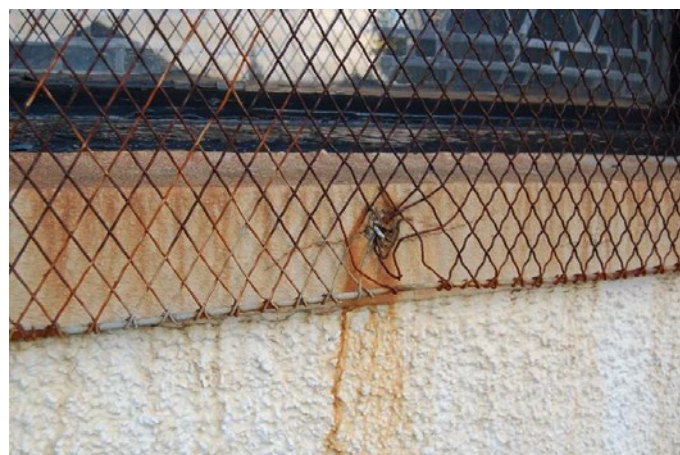
52

**South Elevation:**  
Corrosion of window grille fixings causing cracking to window cill.

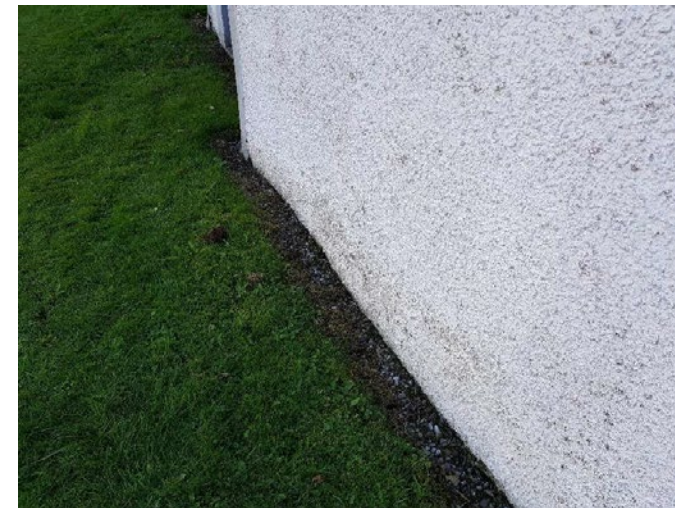
54

**North Elevation:**  
Soil and vegetation in perimeter gravel trench could hinder drainage.

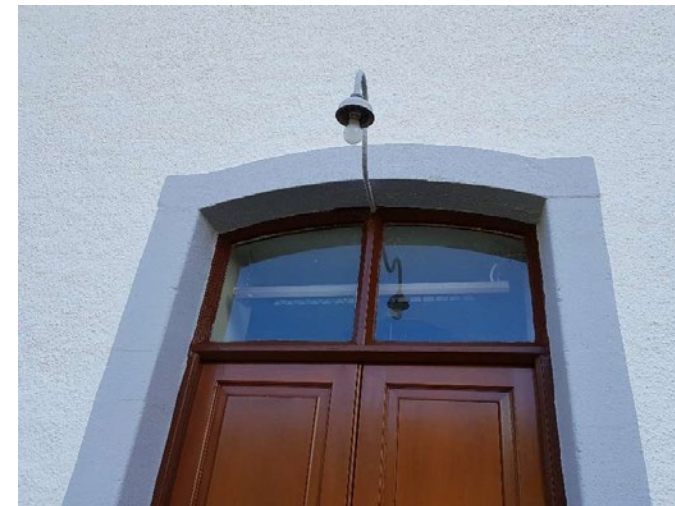
55

**West Elevation:**  
Cover missing from external light fitting. Non IP rated fitting.

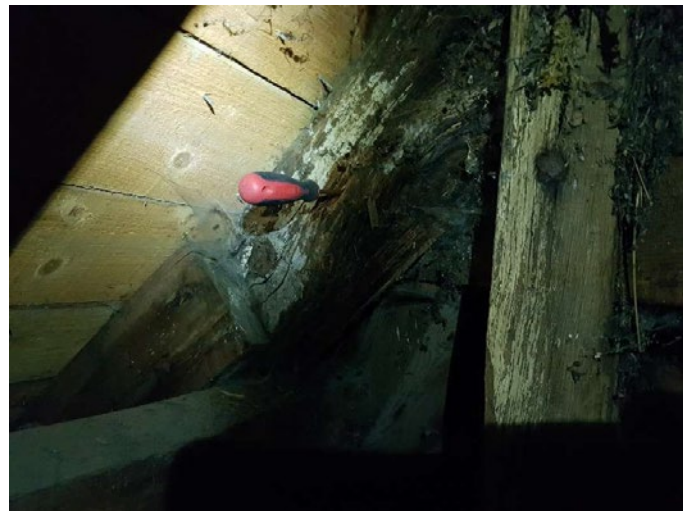
57

**Roofspace:**  
Rotten rafter in roofspace

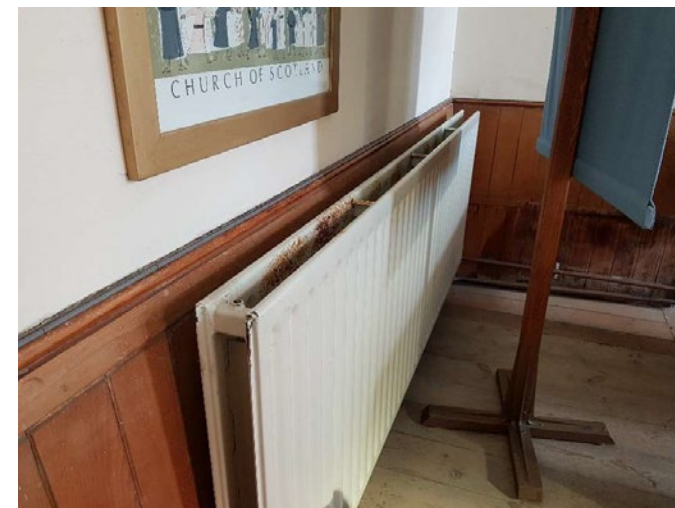
78

Corrosion to radiators.

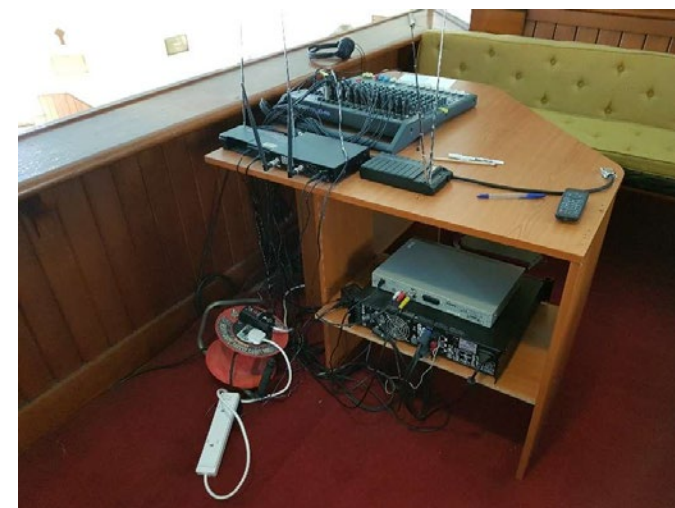
79

Use of extension leads. No evidence of any Portable Electrical Appliance Testing (PAT).

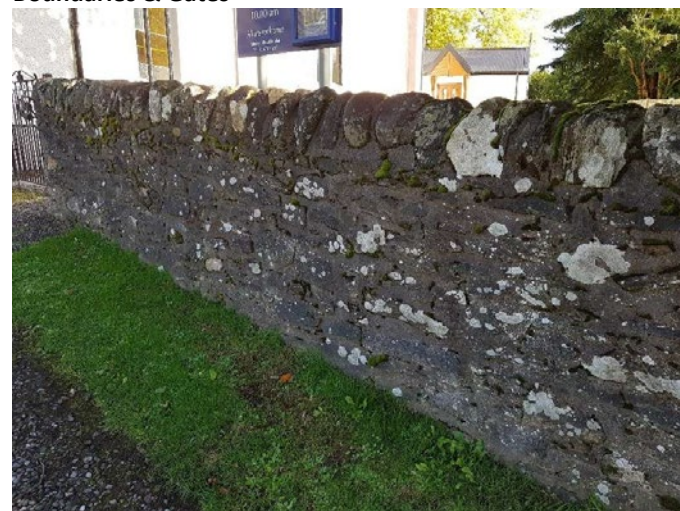
81

Stone boundary wall to west heavily pointed with hard cement mortar.

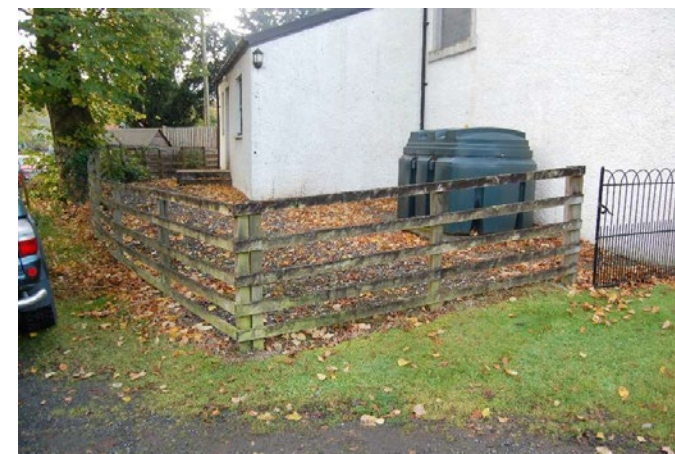
83

Timber post and rail fencing to east boundary. Rotten fence post. Oil tank on concrete slabs.

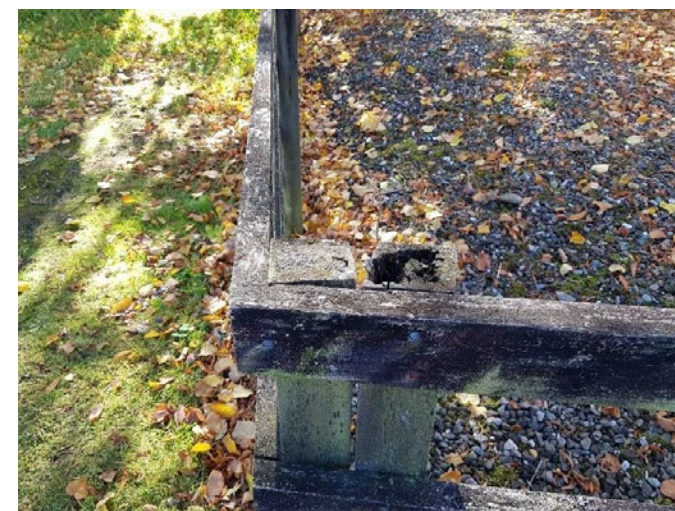
84

Timber post and rail fencing to east boundary. Rotten fence post.

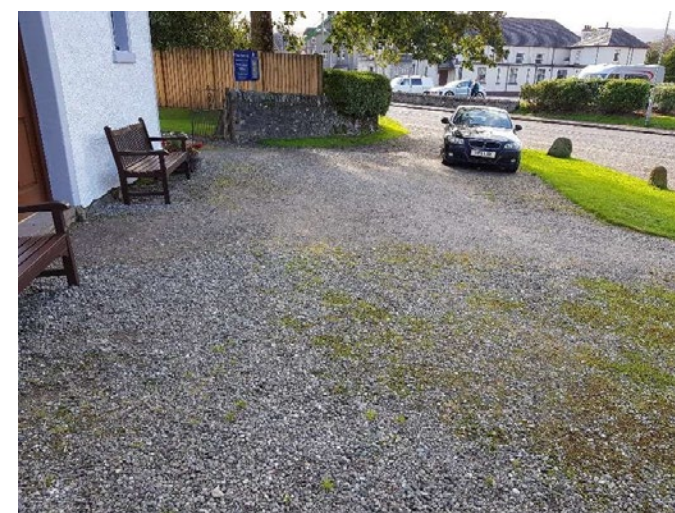
85

Gravel consolidated and dispersed at main entrance to church.

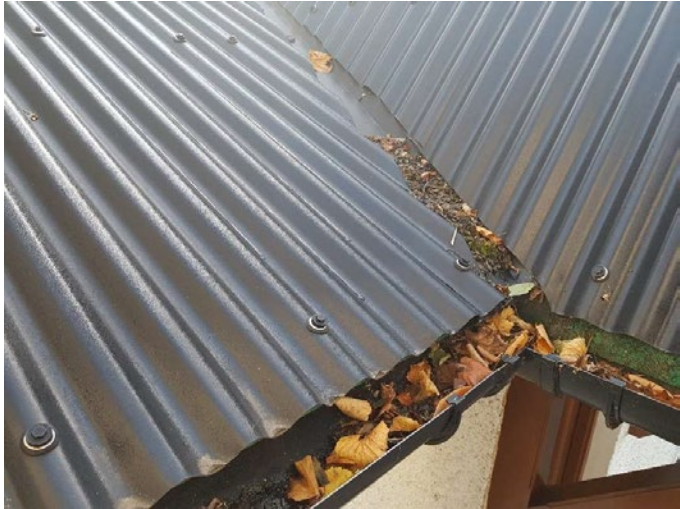
86

Modern corrugated metal roofing with pvc coated finish. Finish degrading at edges. Gutters filled with leaves and other debris.

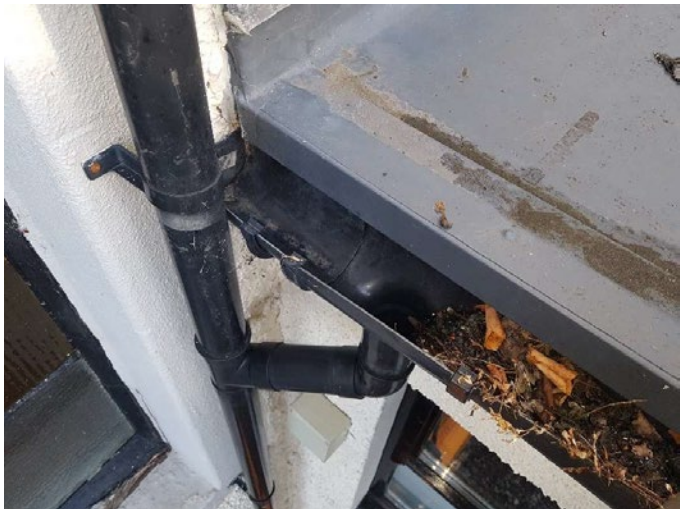
88

Gutter filled with leaves and other debris. No wire rose to outlet to prevent blockage of downpipe.

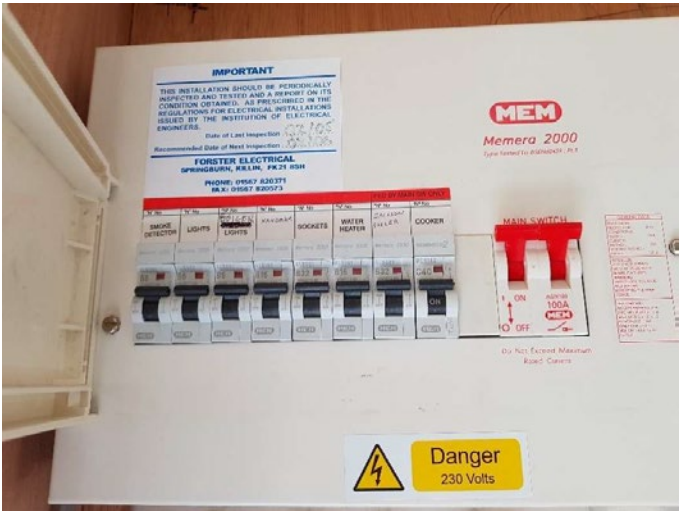
96

**Electrical Installation:**  
Date of last inspection 02/05 and therefore well overdue.

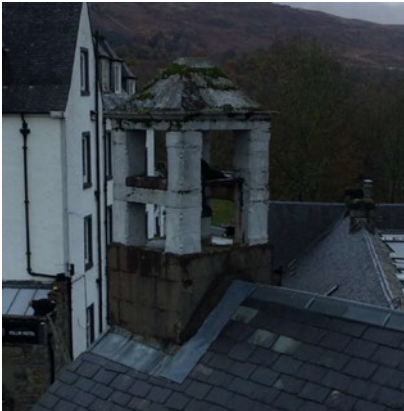
Photograph 02 - Roofers photograph showing overall bell tower construction

Overall the bell tower appears to be out-of-plumb with a lean to the south. This could be suggestive of movement in the supporting structure below. Alternatively the lean may be due to deterioration of the stonework and it's fixings with a resulting sway of the masonry bell tower structure above roof level.

Ferrous fixings appear to have suffered moderate to severe corrosion. In at least one position this appears to have caused a stone to split.

The inappropriate cement render has begun to crack and spall. This represents a potential hazard, as sections of material may fall from height.

The general condition of the bell tower structure is poor and repair work is recommended to be undertaken as soon as practically possible.

It is likely that some sections of stone will have to be replaced. It is our expectation that it will not be possible to do so whilst keeping the bell tower in situ. We therefore anticipate the stonework will have to be dismantled to allow repair. The construction and condition of individual stones should be assessed during the process. Care should be taken during dismantling, with the assumption that all stonework may be reused.

Ferrous fixings should be carefully removed, with replacement stainless steel pins and cramps installed to tie stones together in their original form.
